Service Bulletin

Bulletin No.: 24-NA-238

Subject: Missing Circuits for Trailer Brake Lighting

Brand:	Model:	Model Year:		VIN:		Engine:	Transmission:
		from	to	from	to		
Cadillac	LYRIQ	2024	2024	-	-	S76	All

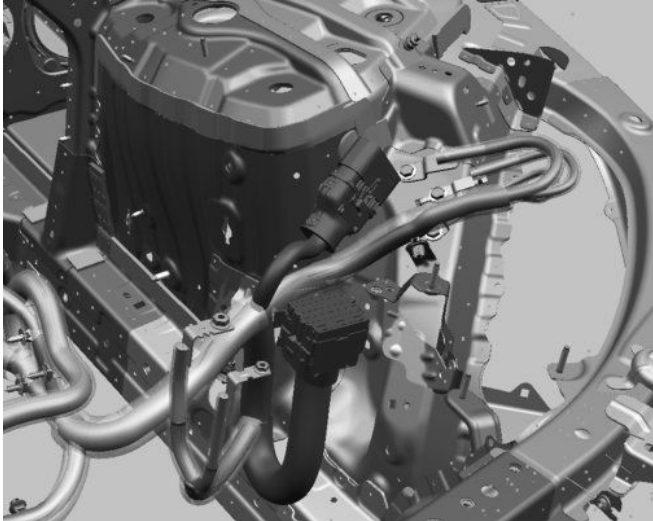
6755005

Highlighted in red is the wire routing. The 2 circuits go between these two connectors.

The circuits are only missing on the engine harness. Only circuits 7055 and 2109 need to be added to the engine harness from connector 13530982 (front inline to body) to the UEC connector.

Technician will need to use two sealed terminated-leads (refer to eSI for correct terminated lead), spliced in the center (resulting in one wire with leads on each end) for each circuit.

7055: Inline 13530982 PIN 22 to UEC X103 PIN 11

2109: Inline 13530982 PIN 24 to UEC X103 PIN 46
