Service Alert

Mazda North American Operations
Irvine, CA 92618-2922

| Subject: TELEMATICS COMMUNICATION UNIT (TCU) REPLACEMENT / ACTIVATION PROCEDURE | Service Alert No.: SA-070/24 |

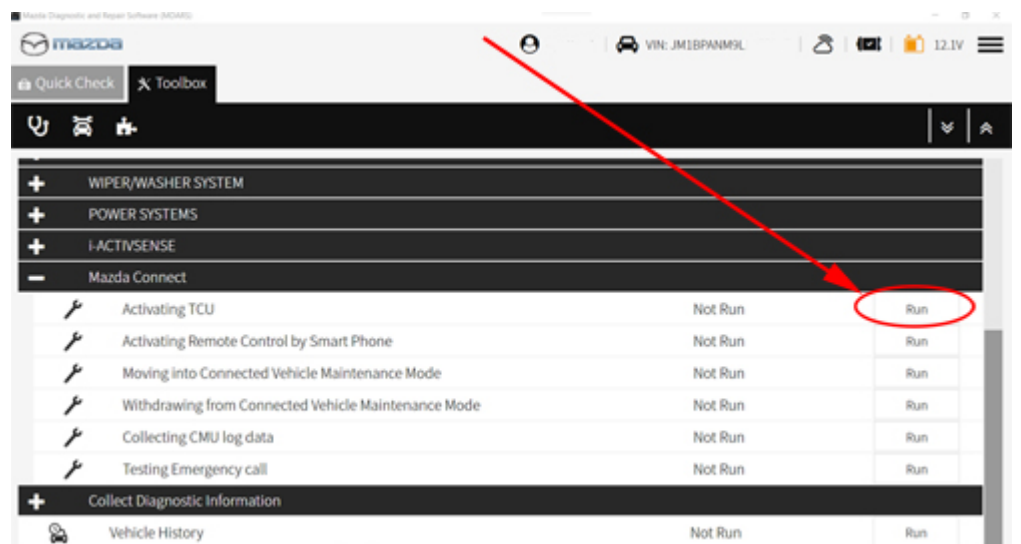
NOTE: MDARS may show "Incomplete". This may be caused by:

- Advanced key is not in the vehicle.
- Connected vehicle maintenance mode is enabled.
- Pacemaker radio wave interference prevention is enabled.
- key transmitter power saving function is enabled. See [SA-020/21](#).

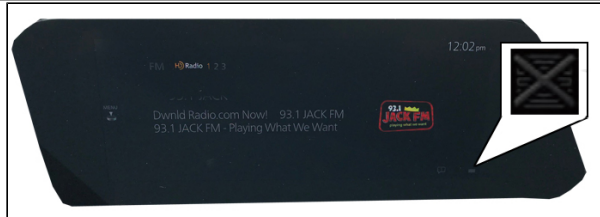
If customer was not previously enrolled, reception strength icon will show "X", this is a normal Deactivation Mode function.

Customer/Dealer can activate CV services anytime via MyMazda app (there just might be a slight delay in making the backend connection since it was temporarily deactivated).

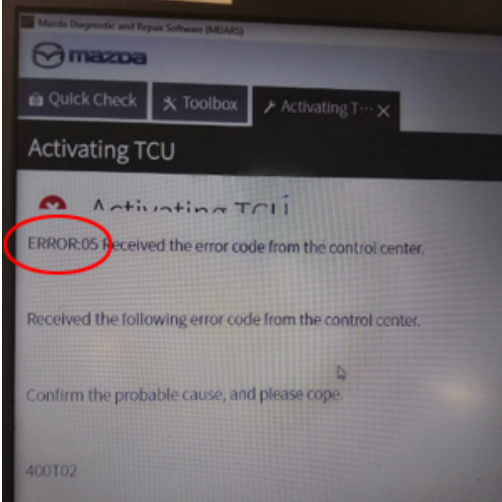
| ERROR:05 | Error code 400t02 |

- If DTC U2050:55-TCU (Activation of remote control not implemented) is stored, go to TSB [09-013/20 - DTC U2050:55 STORED AFTER REPLACING OR REPROGRAMMING TCU](#).
- If the TCU was not replaced and MDARS shows error code 400t02 and/or ERROR:05, TCU activation was previously completed. Ignore these errors as TCU activation is not required.
