WPS2 - Replacing Spoiler Drive (Workshop Campaign)

Vehicle Type: **911 GT3 RS (992)**

Model Year: **2023**

Concerns: **Spoiler drive**

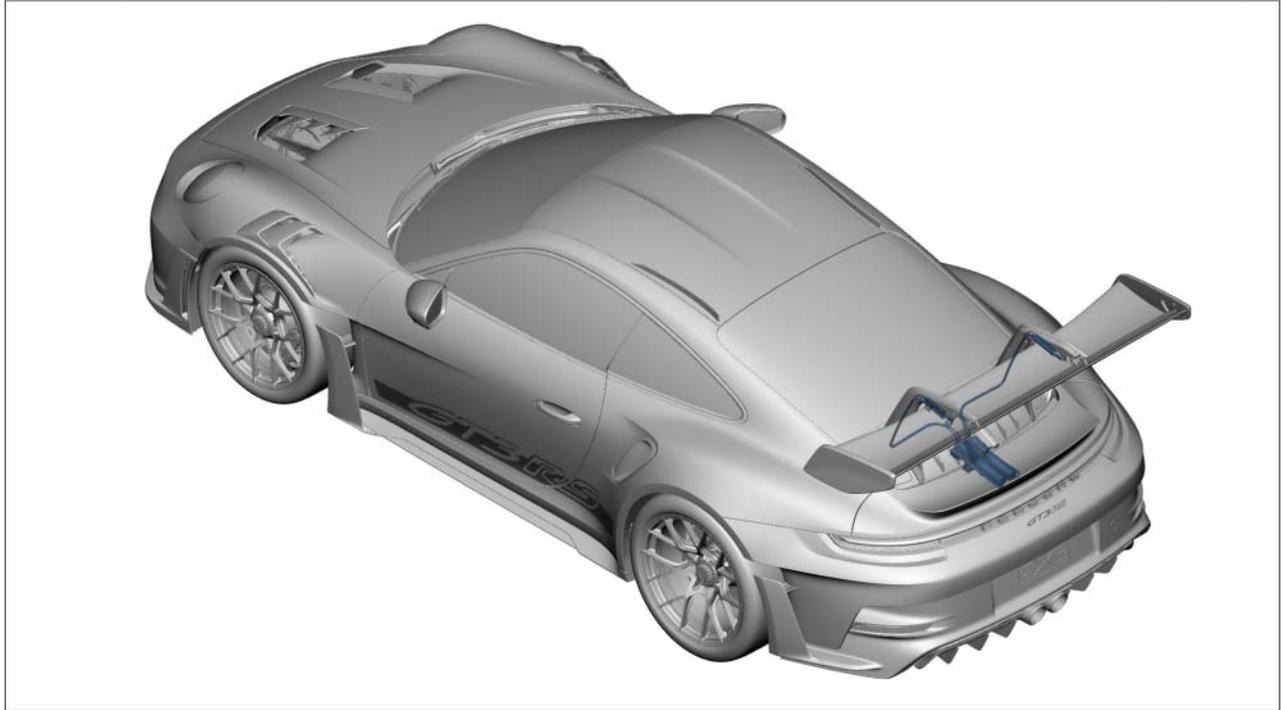
Spoiler drive installation position

Action: Replace spoiler drive.

The spoiler drive must always be replaced in pairs on both sides of the vehicle. Replacement on only one side is not permitted.

- 1 Replace spoiler drive on both sides.
⇒ *Workshop Manual '66725531 Replacing spoiler drive'*
- 2 Enter the campaign in the Warranty and Maintenance logbook.
