Service Bulletin

Bulletin No.: PIE0806

Subject: Engineering Information - (EI Lite) (Picture Only) Rocker Moldings Experiencing Poor Fit, Loose Parts, Broken Clips and/or Warp

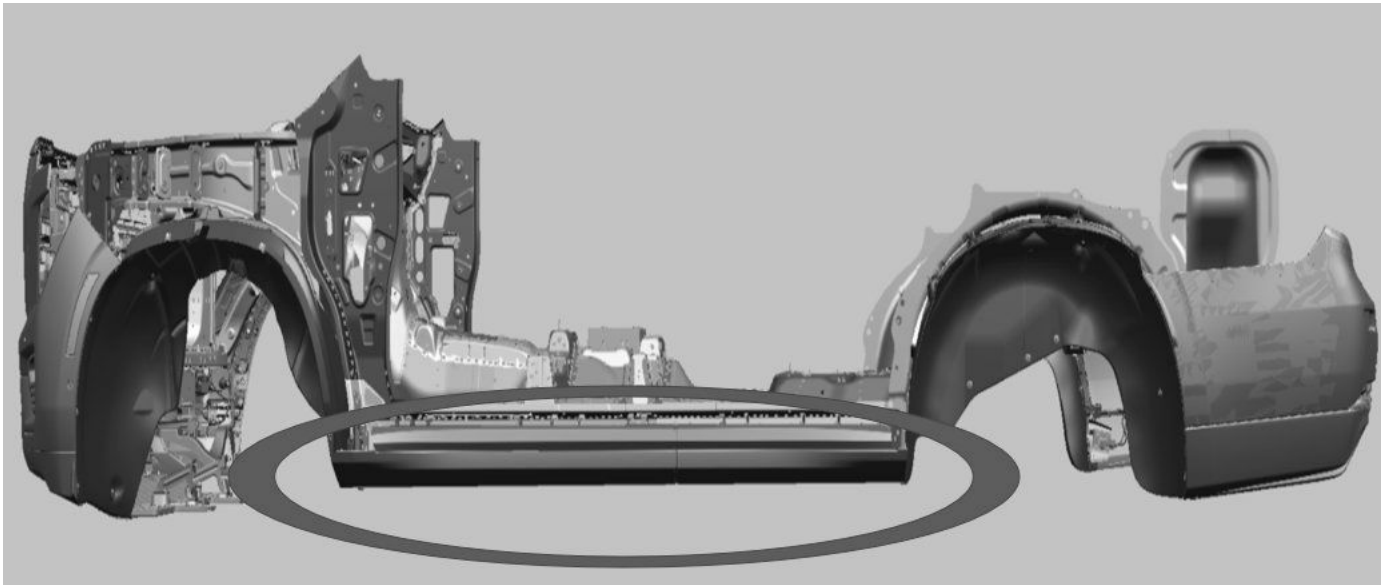
6751317

1. Take a clear picture of the entire area of the vehicle showing the location of the issue area, as shown in the picture above.

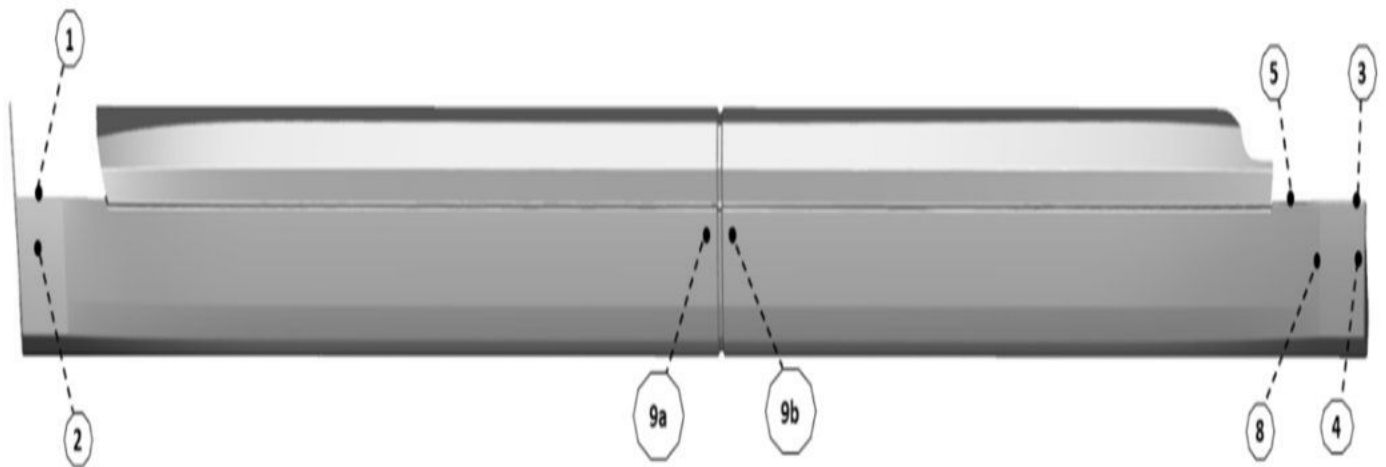
6750948

2. Take a clear close-up picture of the issue area and note the area of concern, as shown in the pictures above
