9x1 - Interior Door Panel Warps Along the Top Surface

Advanced Technical Information

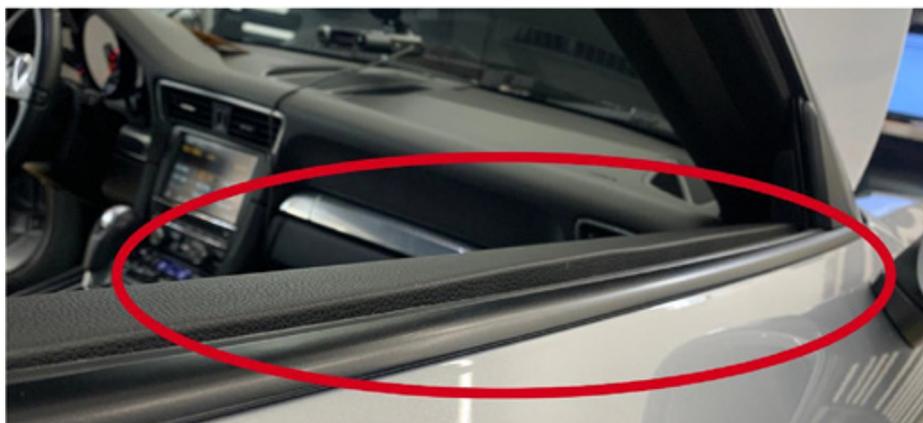
Figure 1

The customer complains that the interior door panel is deformed along the top surface. This condition is possible on both the driver and the passenger door panels.

Over time, it is possible that the glue that secures the door panel trim will deteriorate. This deterioration is accelerated with prolonged or frequent exposure to heat.

1. Please document the affected door panel(s) with pictures, and attach the pictures to the PCSS job.
2. Replace the affected door panel(s) with the most recent available parts. Updated parts to address this issue have been in production since June 10, 2016.
