Check engine light active - Fault P3007F1, P3007F2, P300CA8, or P300CA9 present in CDI control unit

Topic number	LI14.30-N-075882
Version	4
Function group	14.30 - Secondary air injection
Date	11/28/24
Validity	Model 907 with engine 654
Reason for change	Remedy updated

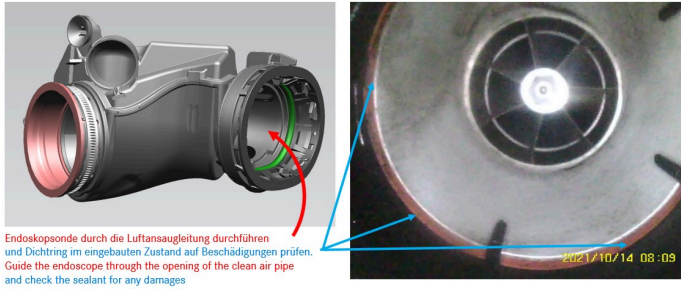
Attachments	
File	Description
Dichtring_Sealant.jpg

- If there is a leakage upstream of the exhaust gas turbocharger. Please refer to the file attached as "Dichtring_Sealant.jpg."
- There is a defective hot film mass air flow sensor or a hot film mass air flow sensor that is affected by incorrect airflow (this can be due to a clogged or deformed air filter). Refer to the attached file "Luftfilter_air_filter."
- If the intake manifold (charge air distribution line) or the charge air cooler is carbonized. For more information, see the file attached as "Saugrohr_intake_manifold.jpg."
- If the timing is misadjusted.
- If there is carbonization or incomplete closure of the high-pressure or low-pressure exhaust gas recirculation valve, particularly in the housing intermediate flange connected to the high-pressure exhaust gas recirculation valve (which is linked to the exhaust back pressure sensor).

4) Inspect the sealing ring between the exhaust gas turbocharger and the clean airline (see the annex "Dichtring_Sealant_nok") for damage while in the installed position, using an endoscope. If any issues are detected, perform the necessary repairs.

4) Check sealing ring between the exhaust gas turbocharger and clean airline (see annex "Dichtring_Sealant_nok") for damage in the installed state by means of an endoscope.

<p>Endoskopspeende durch die Luftansaugleitung durchführen und Dichtring im eingebauten Zustand auf Beschädigungen prüfen. Guide the endoscope through the opening of the clean air pipe and check the sealant for any damages</p>	
Gehaeusezwischenflansch_Intermedidate_Flange.jpg

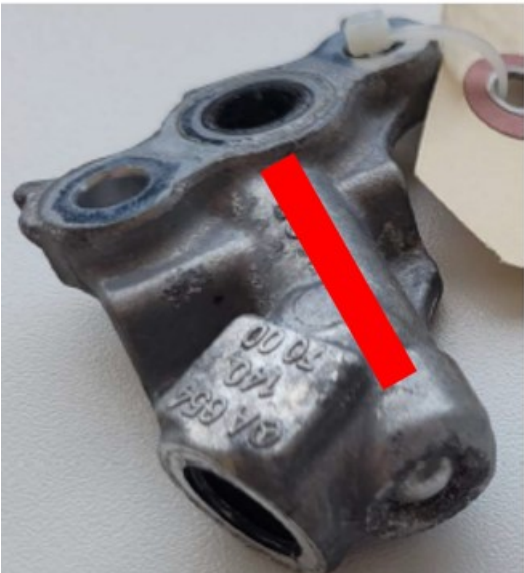
- There is a leakage upstream of the exhaust gas turbocharger.
- The housing intermediate flange located at the high-pressure exhaust gas recirculation valve (where the exhaust back pressure sensor connects) is carbonized or clogged. Please refer to the attached file "Gehaeusezwischenflansch_intermediate_flange.jpg."

- Carbonization of the intermediate housing flange at the high-pressure EGR valve, specifically at the connection for the exhaust back pressure sensor.

2) Inspect the housing intermediate flange on the high-pressure exhaust gas recirculation (EGR) valve, specifically at the connection for the exhaust back pressure sensor. Use a flashlight to check for any inconsistencies or carbon buildup.

1) Inspect the housing intermediate flange on the high-pressure exhaust gas recirculation (EGR) valve, specifically at the connection for the exhaust back pressure sensor. Use a flashlight to check for any inconsistencies or carbon build-up.

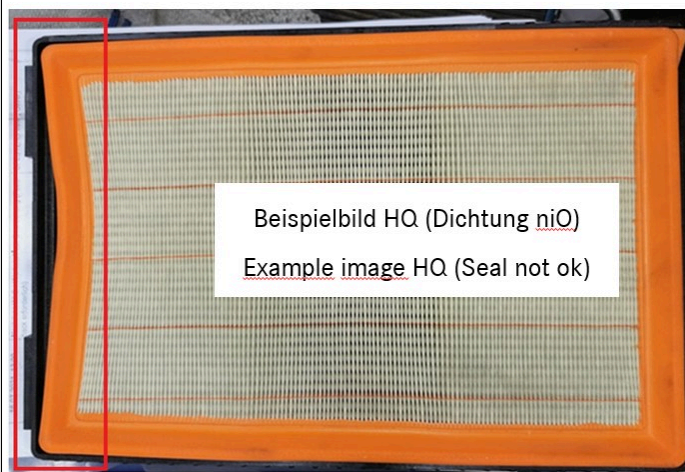
Luffilter_air_filter.jpg

- The engine timing is misadjusted.
- There is a defective hot film mass air flow sensor or a hot film mass air flow sensor that is affected by incorrect airflow (this can be due to a clogged or deformed air filter). Refer to the attached file "Luftfilter_air_filter."
- There is carbonization or incomplete sealing of the high-pressure or low-pressure exhaust gas recirculation valves.

6) Conduct a visual inspection of the air filter for dirt or deformation.

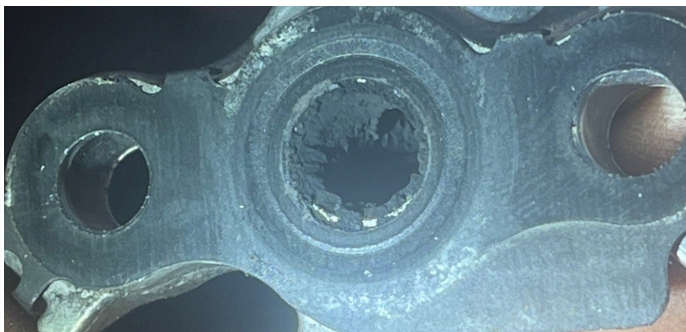
[verstopfter_Gehaeusezwischenflansch_clogged_Intermediate_Flange.jpg](#)

****Note:**** This is only relevant if the correction value in load range 1 is less than -8%. See the attached file "verstopfter_Gehaeusezwischenflansch_clogged_Intermediate_Flange.jpg."

****Note:**** This step is only necessary if the correction value for air intake in load range 1 is less than -8%.

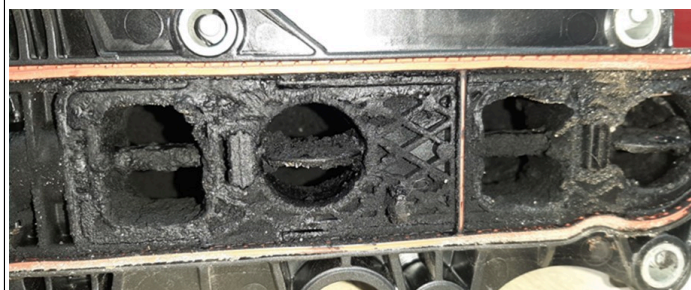
[Saugrohr_Intake_manifold.jpg](#)

- There is a leakage downstream of the exhaust gas turbocharger.
- The charge air distribution line (intake manifold) is severely carbonized. See file in annex "Saugrohr_intake_manifold.jpg".
- There is a defective hot film mass air flow sensor or a hot film mass air flow sensor that is affected by incorrect airflow (this can be due to a clogged or deformed air filter). Refer to the attached file "Luftfilter_air_filter."

- There is a leak located downstream of the exhaust gas turbocharger.
- The charge air distribution line (intake manifold) is heavily carbonized. Please refer to the attached file "Saugrohr_intake_manifold.jpg" for reference.
- If there is carbonization or incomplete closure of the high-pressure exhaust gas recirculation valve, particularly in the housing intermediate flange connected to the high-pressure exhaust gas recirculation valve (which is linked to the exhaust back pressure sensor).

- Check the charge air distribution line for carbon buildup.
