Service Bulletin

Bulletin No.: 24-NA-168

Subject: Radio Software Version Z172.6 – Multiple Updates for IOK

Brand:	Model:	Model Year:		VIN:		Engine:	Transmission:
		from	to	from	to		
Chevrolet	Corvette	2024	2024				
GMC	Hummer EV Pickup	2022	2023	—	—	—	—
	Hummer EV Pickup	2024	2024				
	Hummer EV SUV

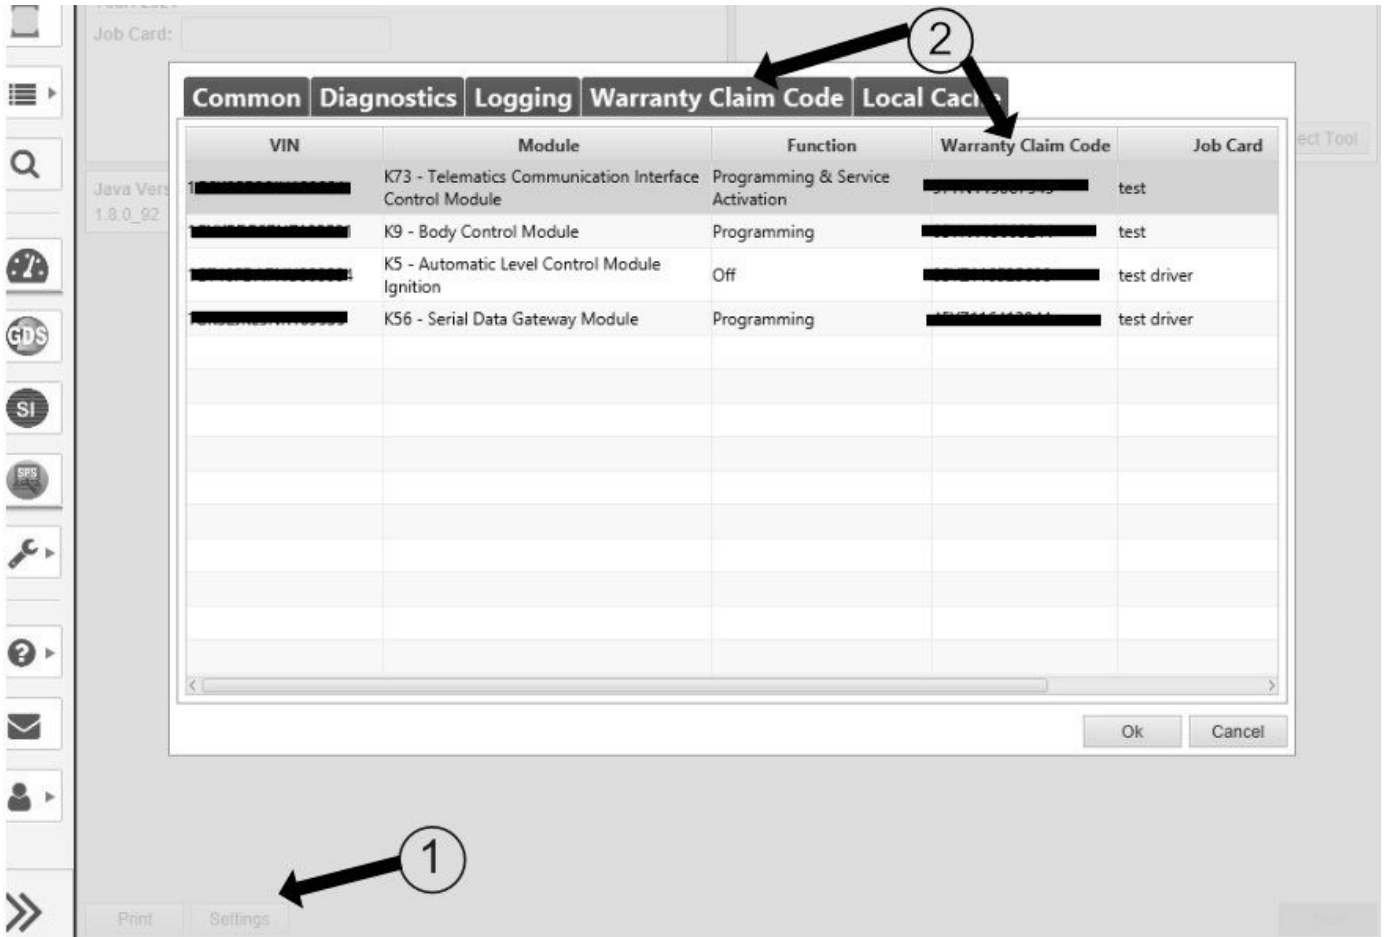
6125774

If the Warranty Claim Code was not recorded on the Job Card, the code can be retrieved in the SPS2 system as follows:

1. Open TLC on the computer used to program the vehicle.
2. Select and start SPS2.
3. Select Settings (1).
4. Select the Warranty Claim Code tab (2).

The VIN, Warranty Claim Code and Date/Time will be listed on a roster of recent programming events. If the code is retrievable, dealers should resubmit the transaction making sure to include the code in the SPS Warranty Claim Code field.
