# Technical Service Bulletin

## 37 Noises after selecting a gear at idling speed when vehicle is stationary, noises when driving in different gears

37 24 28 2074806/2 November 22, 2024. Supersedes Technical Service Bulletin Group 37 number 24-20 dated July 31, 2024 for reasons listed below.

Model(s)	Year	VIN Range	Vehicle-Specific Equipment
A6	2016 – 2020	All	Not Applicable
A4	2017 – 2020		
A5, A5 Cabriolet, A5 Sportback, and Q5	2018 – 2020		
A7	2019	000001 - 046382	
	2020	All	
A6 allroad	2020

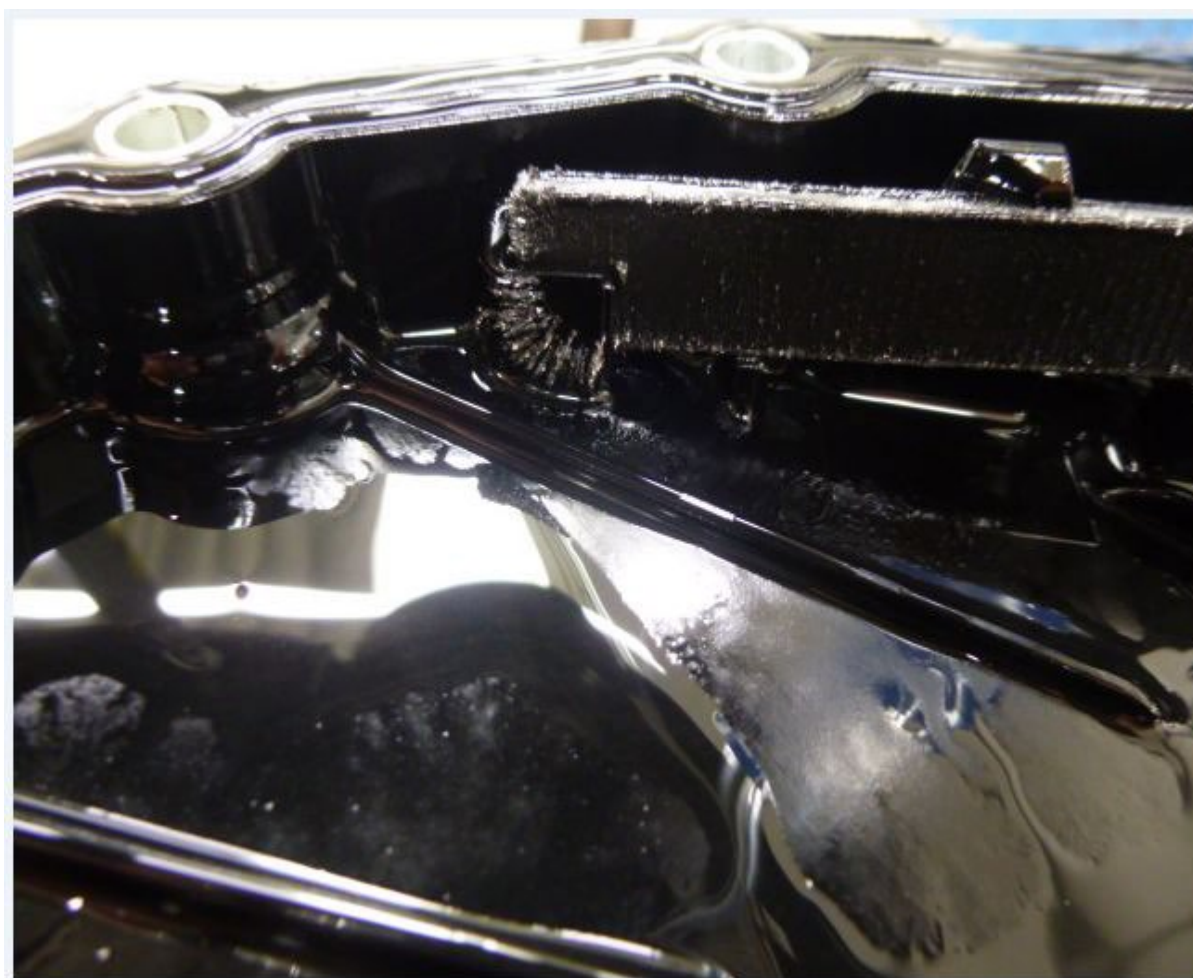
- Abrasion visible on the permanent magnets of the oil pan (see Figure 5).

*Figure 5. Abrasion is visible on the permanent magnets of the oil pan.*

- Replace the high-pressure filter, the low-pressure filter and the intake filter.
  - After removing the filter, thoroughly **clean** the valve body in this area and **avoid** getting it dirty.
- Replace the permanent magnets in the gearbox oil pan.
- Also replace the ATF.

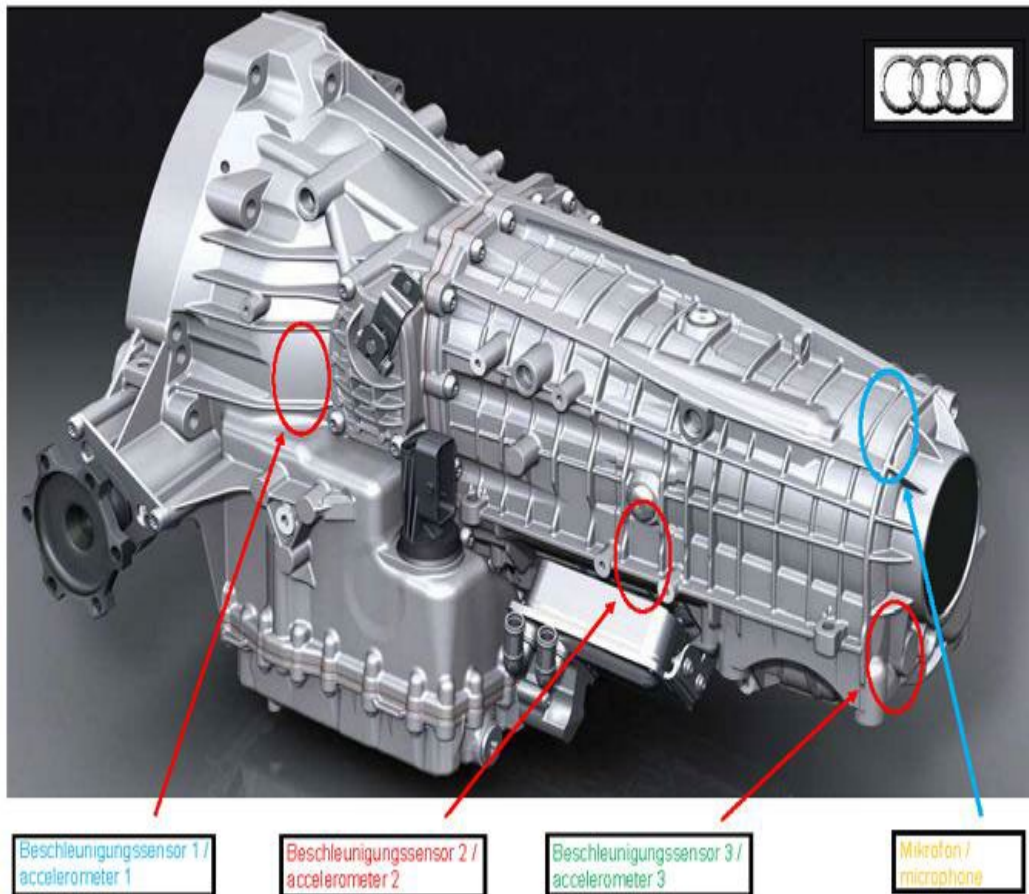
Figure 6. "Measuring points\_page\_1".

- Attach acceleration sensors and microphone as described under “Measuring points\_page\_1” and “Measuring points\_page\_2”.

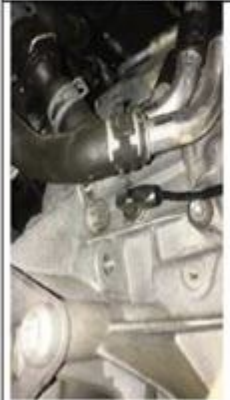
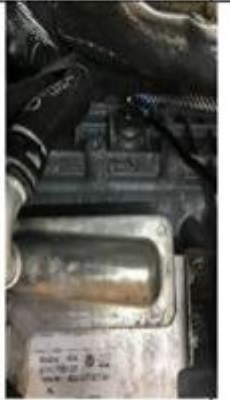
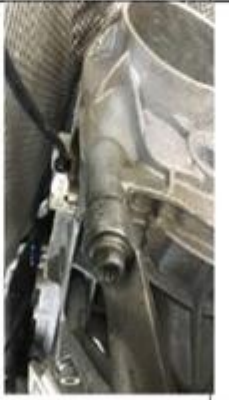
Figure 7. "Measuring points\_page\_2".

Kanal A / canal A	Kanal B / canal B	Kanal C / canal C	Kanal D / canal D
Beschleunigungssensor 1 / accelerometer 1	Beschleunigungssensor 2 / accelerometer 2	Beschleunigungssensor 3 / accelerometer 3	Mikrofon / microphone

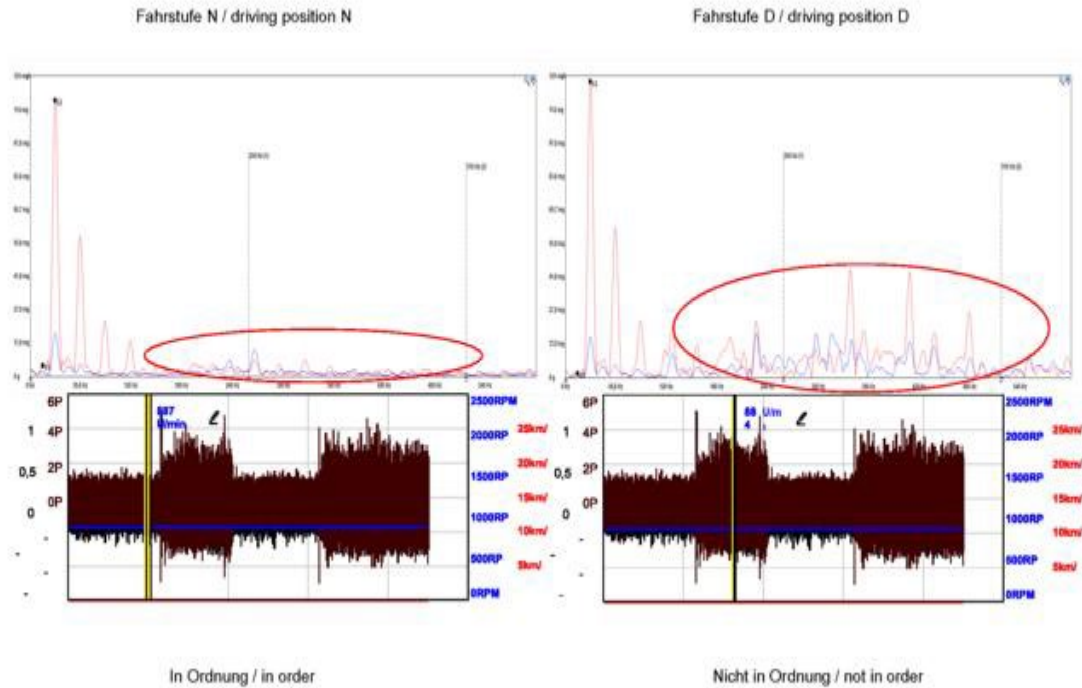
- Analysis of the measurement via acceleration sensor 1/channel A and acceleration sensor 2/channel B.
  - Frequency range of approx. 250-600Hz can be detected here.

**Figure 8.** Please note the visualization showing a measurement in the attachment (“measurement” and “measurement1”).

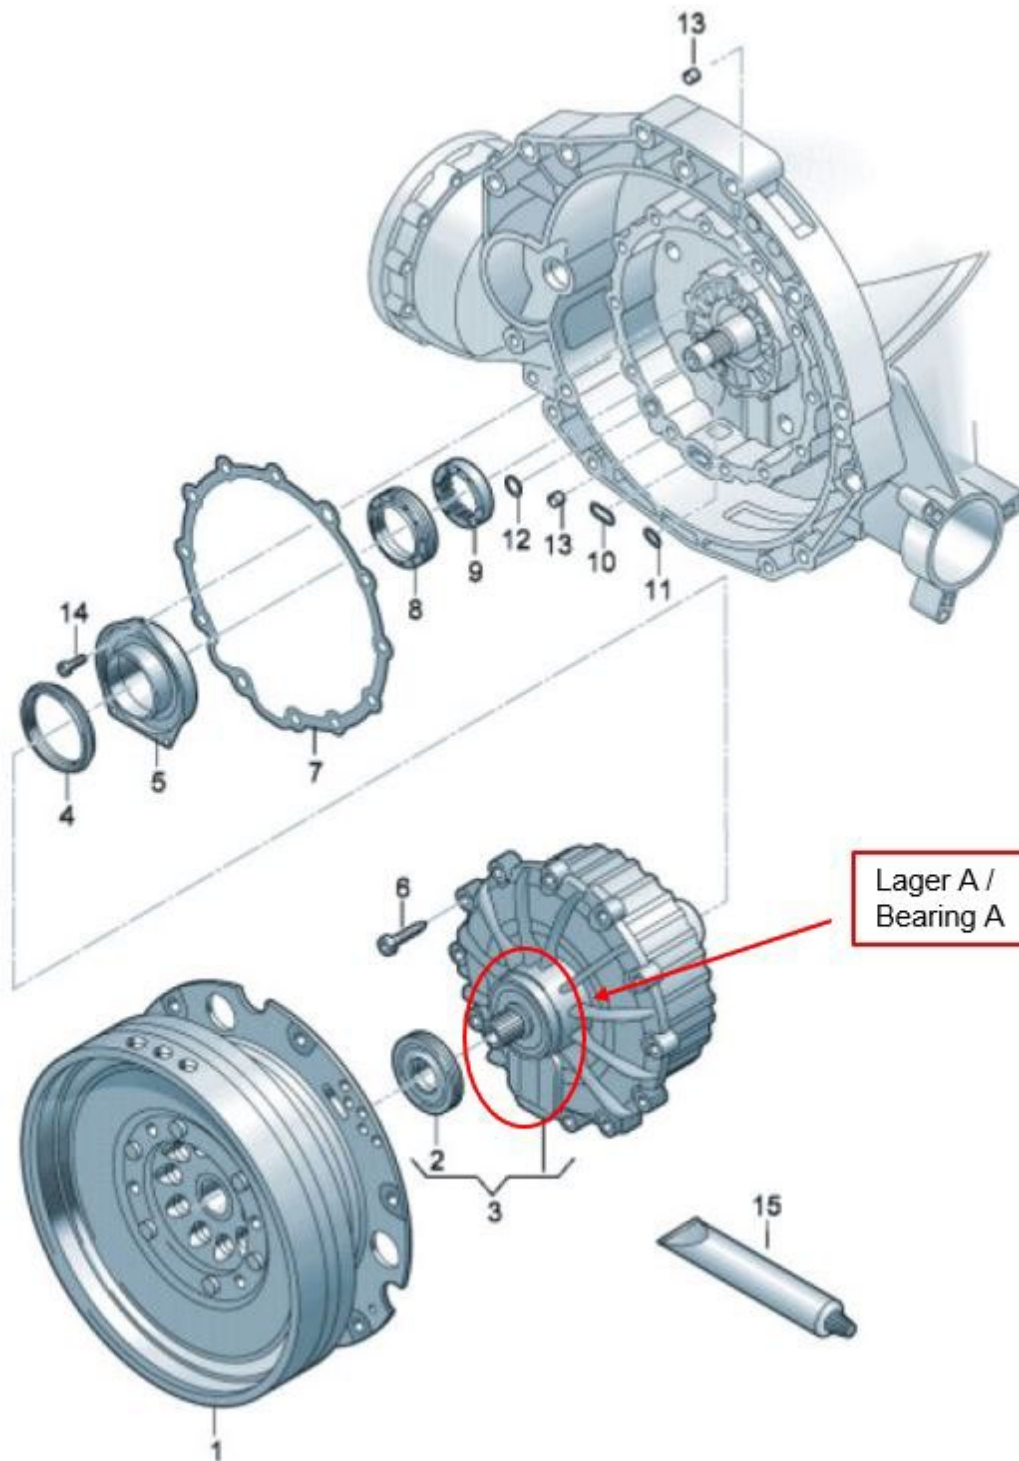
Figure 9. Bearing A on dual clutch.

Bearing A (Figure 9) on dual clutch.

- To do so, remove the oil seal on bearing A (Figure 9 -> marked in red) of the dual clutch that was removed.
- Document any possible malfunctions of bearing A (see Figure 10 -> red arrow) with a photo clearly showing the issue.

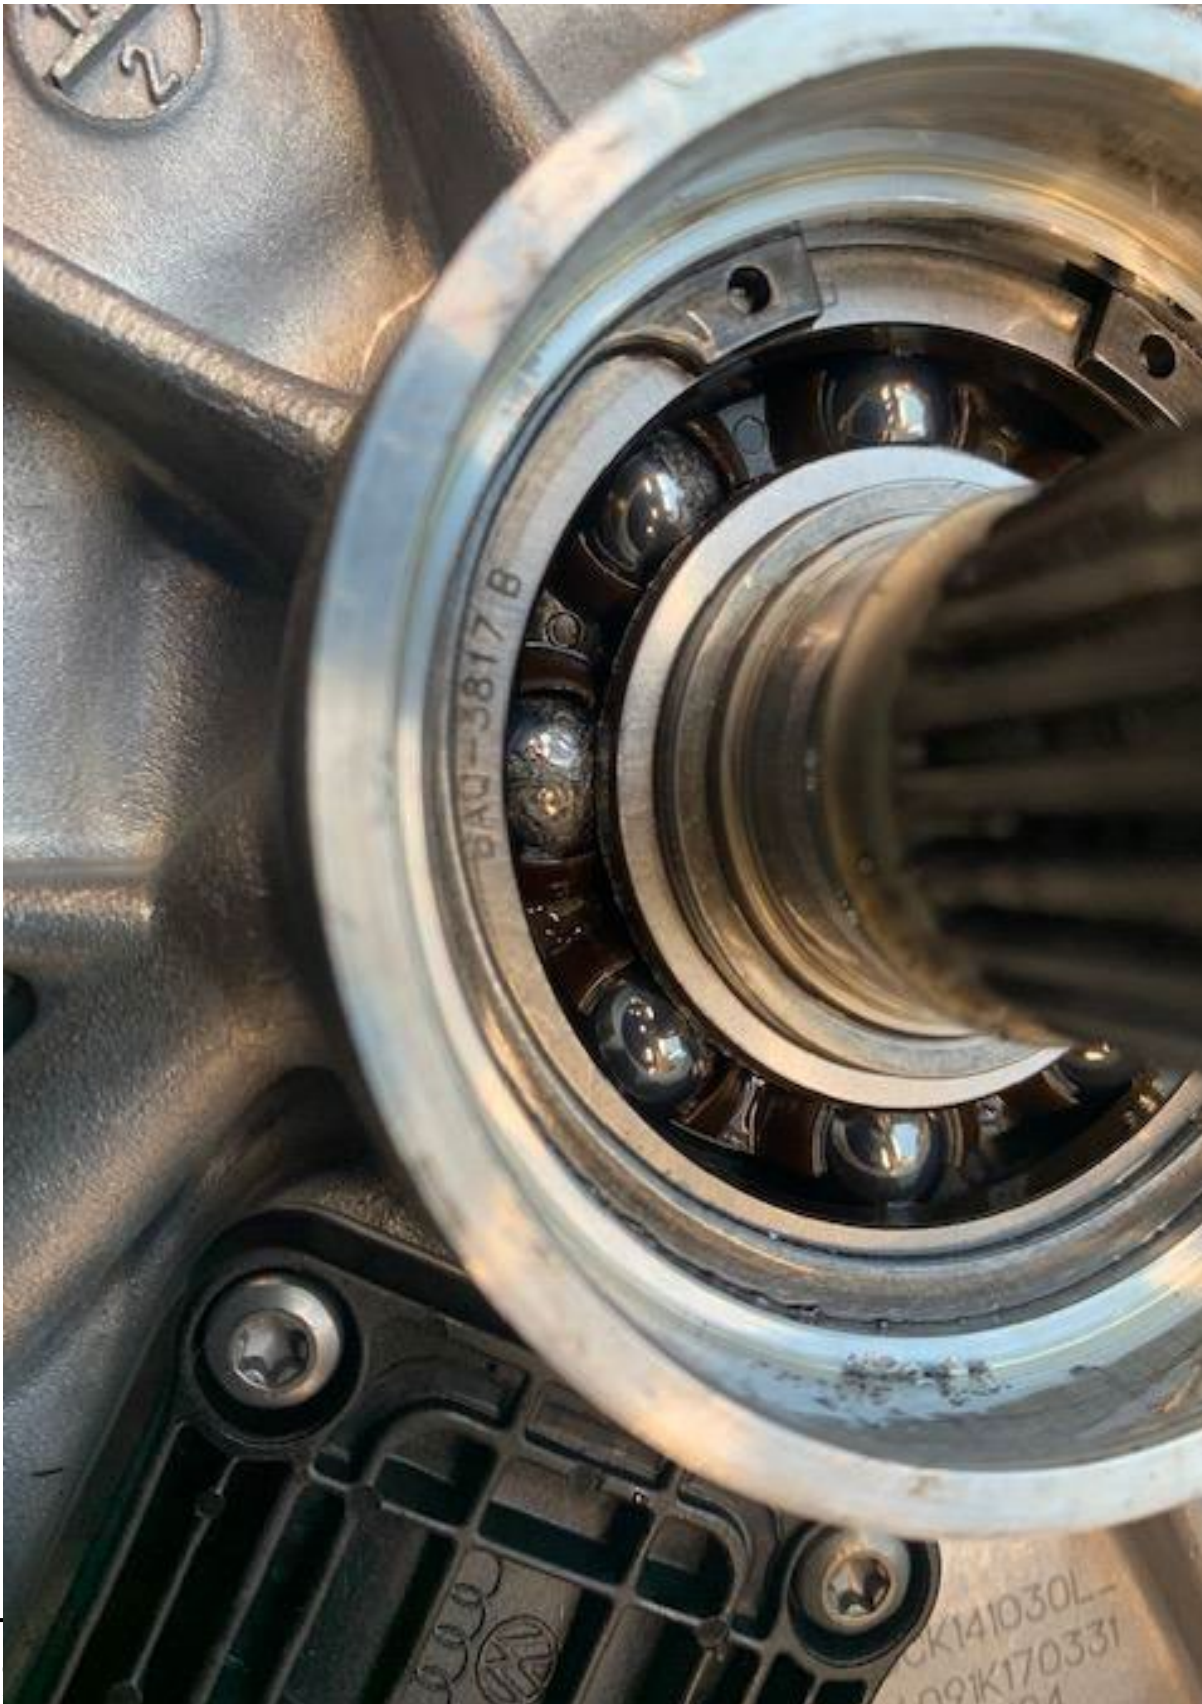
*Figure 11. Bearing A and ballcage.*

- Replace bearing A in cover for dual clutch if you find the following functional issue on bearing A:
  - Wear can be seen on bearing A and ball cage is still in bearing A (see Figure 11).

- Replace the entire dual clutch if you find the following functional issue in the installation space around bearing A:
  - Ball cage no longer in bearing A or irreparable damage to ball cage -> ball guidance no longer provided (see Figures 11 and 12).

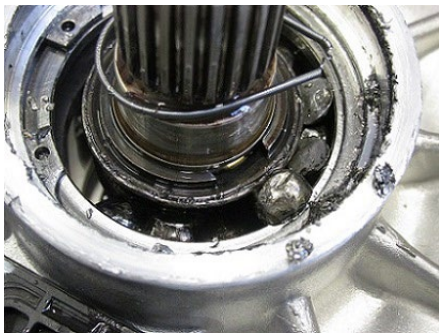
*Figure 12. Damage is irreparable.*

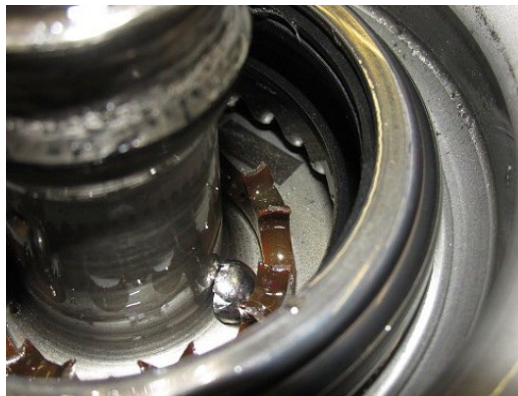
*Figure 13. Damage is irreparable.*
