Technical Service Bulletin

42 Booming noise from rear area while vehicle is moving (depending on vehicle speed/wheel speed) DTC P18F100

42 24 59 2068250/4 November 21, 2024. Supersedes Technical Service Bulletin Group 42 number 24-58 dated November 11, 2024 for reasons listed below.

Model(s)	Year	VIN Range	Vehicle-Specific Equipment
Q4 e-tron, and Q4 Sportback e-tron	2022 – 2025	All	Not Applicable

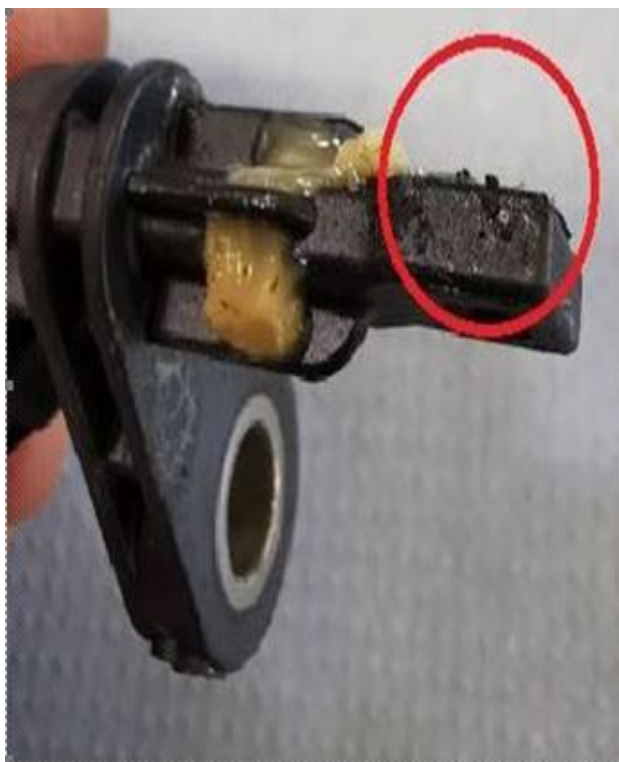
Foreign metallic particles in the area of the wheel speed sensor/wheel hub/wheel bearing/drive shaft (see figure 1, red circle) lead to implausible wheel speed signals.

Figure 2: *Metallic particles in the speed sensor.*

- Thoroughly remove foreign metallic particles from the components with workshop materials.

Do not use magnetic aids/tools to remove the foreign metallic particles as this could cause secondary damage to the sensor ring in the wheel bearing.

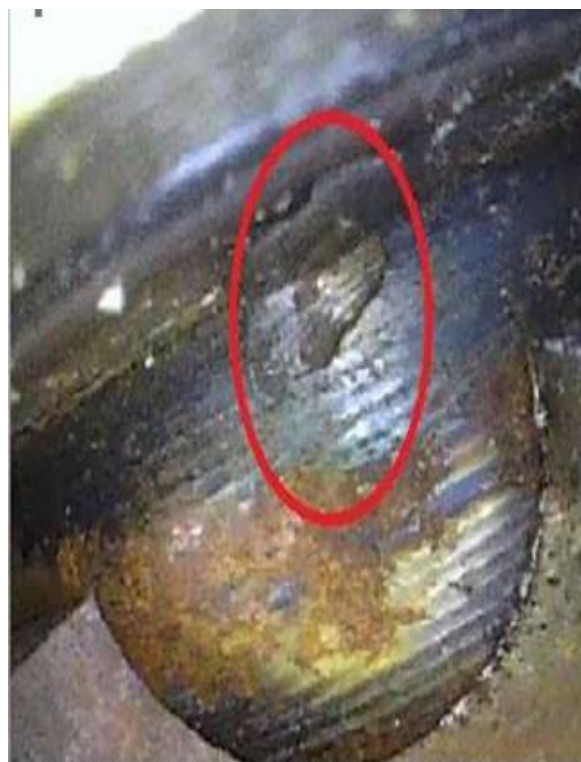
Figure 3: *Metallic particles in the hub.*

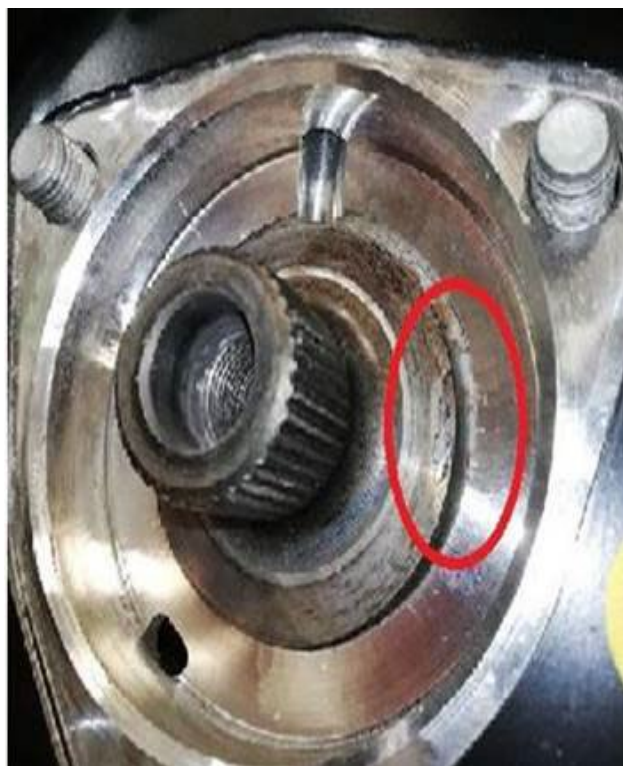
Figure 4: Metallic particles/damage in the wheel hub/bearing.

- If there is damage to the components, the corresponding components must be replaced according to ELSA/ETKA).
- Finally, delete the DTCs.

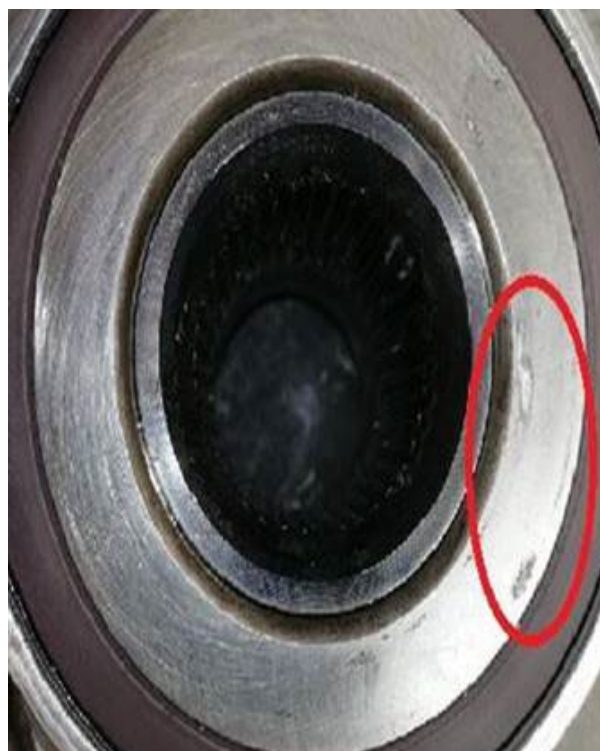
Figure 5: Metallic particles/damage in the wheel hub/bearing.
