# Technical Service Bulletin

## 69 Airbag warning light on, DTC B120E1B

69 24 19 2072023/2 November 22, 2024. Supersedes Technical Service Bulletin Group 69 number 23-02 dated November 15, 2023 for reasons listed below.

Model(s)	Year	VIN Range	Vehicle-Specific Equipment
Q5, Q5 e quattro, Q5 Sportback, SQ5, and SQ5 Sportback	2021 – 2024	All	Not Applicable

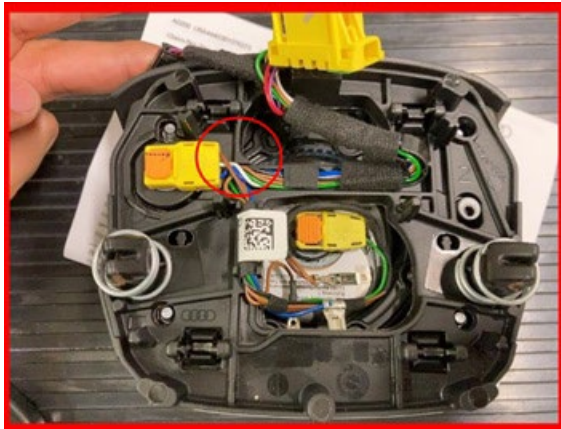
Non-optimal wiring routing causes tension on the release valve connector. This leads to increased resistance during vibrations, which results in an event memory entry being logged.

*Figure 1. Check the routing of the wiring inside the driver airbag.*

3. Replace the airbag wiring harness. Make sure that you route the wiring in such a way that it does not create tension.

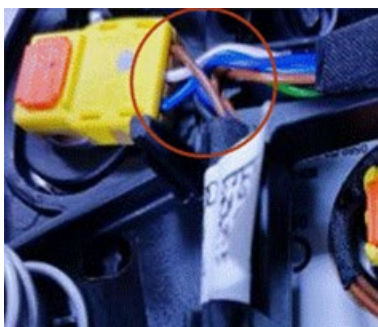
*Figure 2. Check the routing of the wiring inside the driver airbag.*
