# Technical Service Bulletin

## 72 Noise complaint at anchoring point of second row of seats caused by contact between lock and locking mechanism

72 24 60 2060719/3 November 11, 2024. Supersedes Technical Service Bulletin Group 72 number 22-41 dated April 16, 2022 for reasons listed below.

Model(s)	Year	VIN Range	Vehicle-Specific Equipment
Q7	2017 – 2025	All	\\Not Applicable
SQ7	2020 – 2025

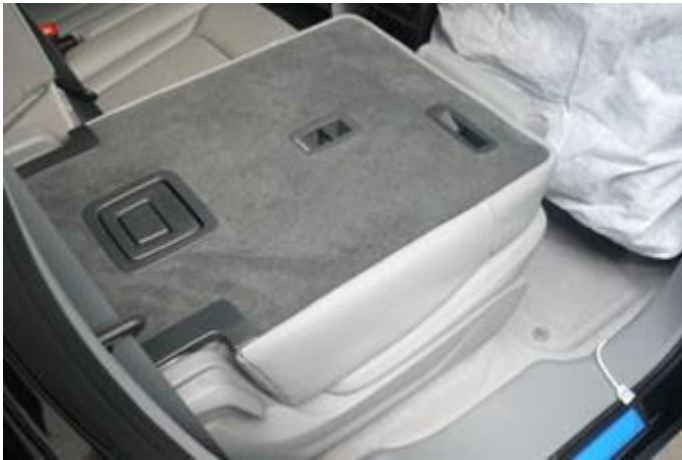
**Figure 1.** Affected second-row seat.

1 Fold the affected seat forward (Figure s 1 – 2).

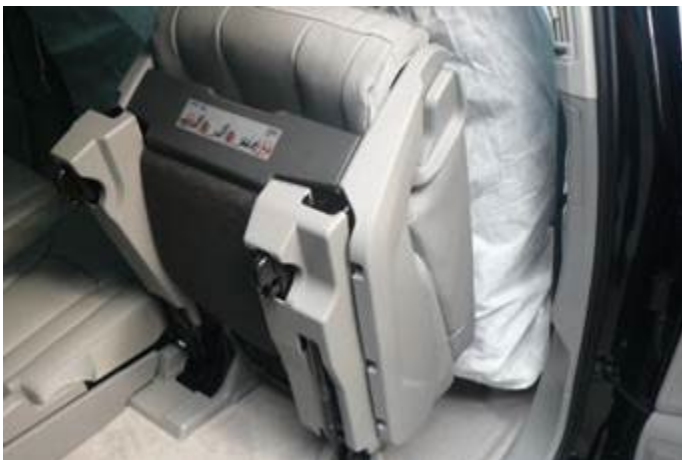
**Figure 2.** Affected seat unlatched and tilted forward.

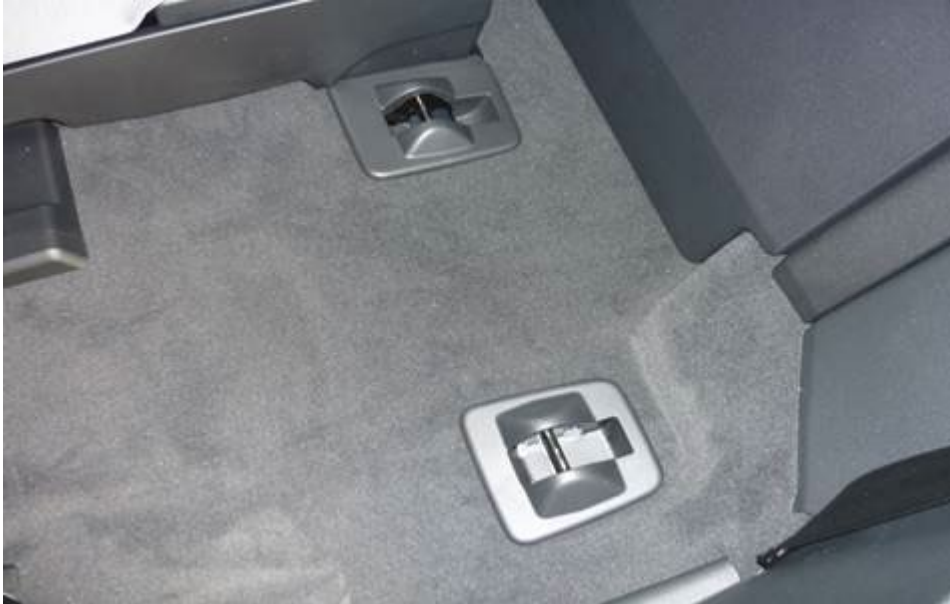
*Figure 3. Outer and inner locking plate with covers installed.*

2 Remove the outer cover for the seat fastener in the floor on the door end (Figure s 3 - 4).

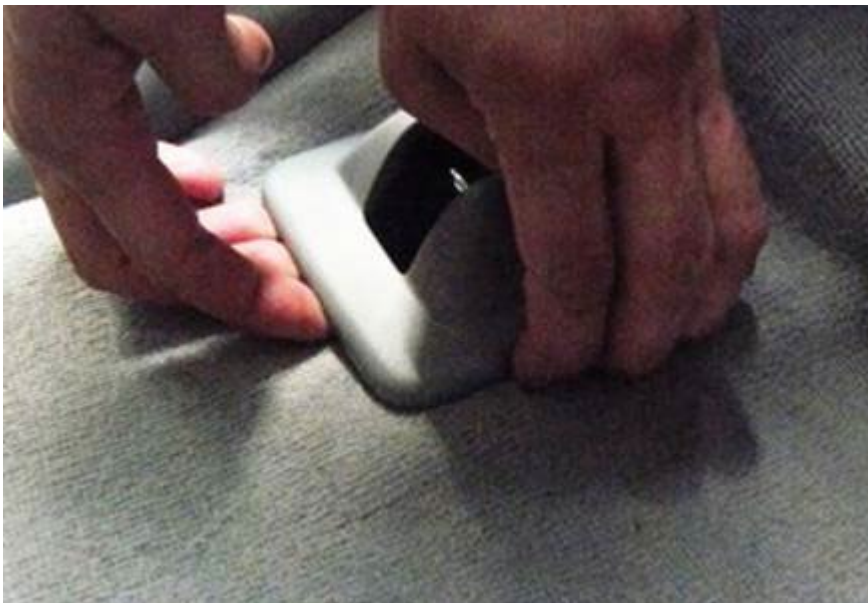
*Figure 4. Remove the outer cover for the seat fastener in the floor on the door end.*

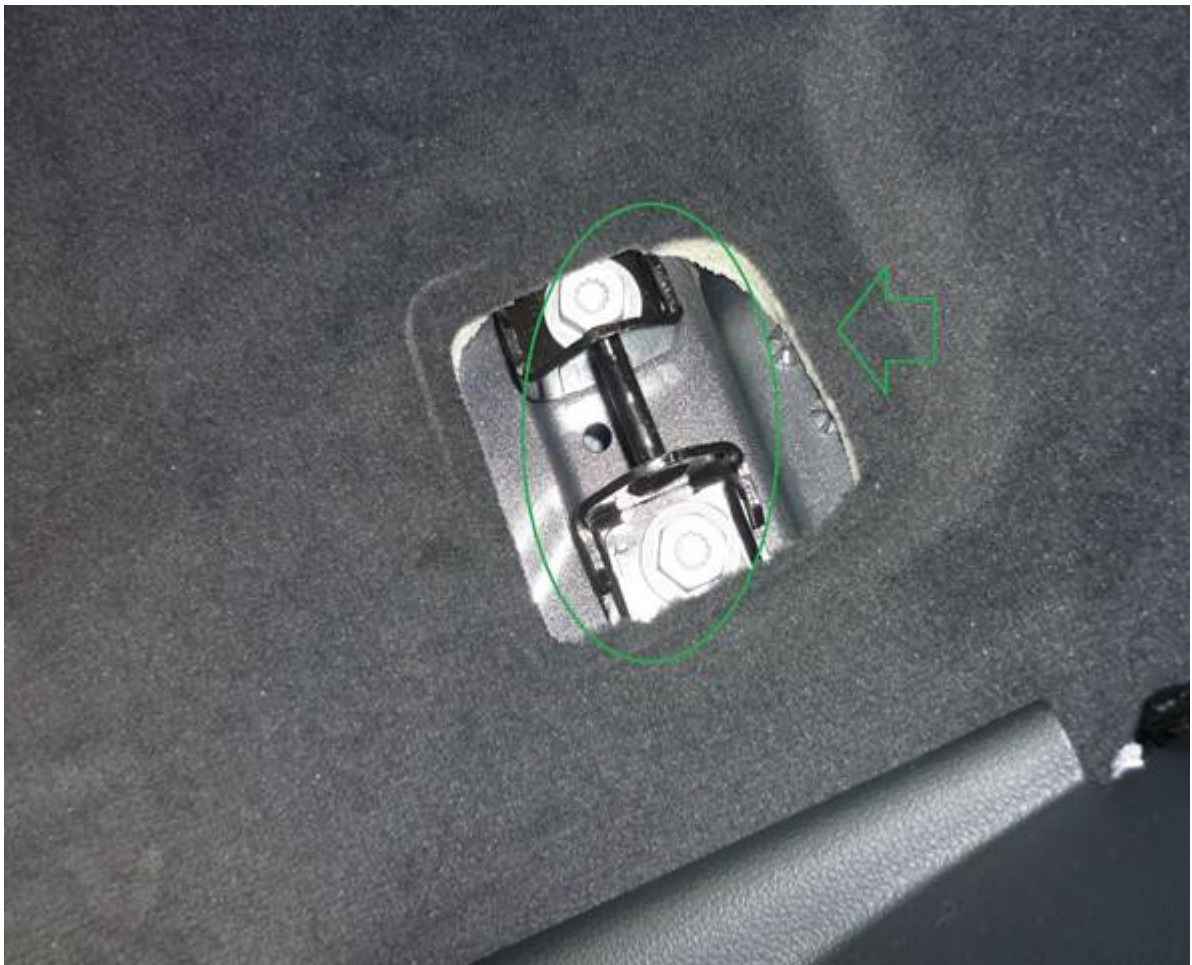
Figure 5. Outer locking plate with cover removed.

- 3 Loosen both bolts and move bar back evenly by about 1.2 mm (Figure s 5 - 6).

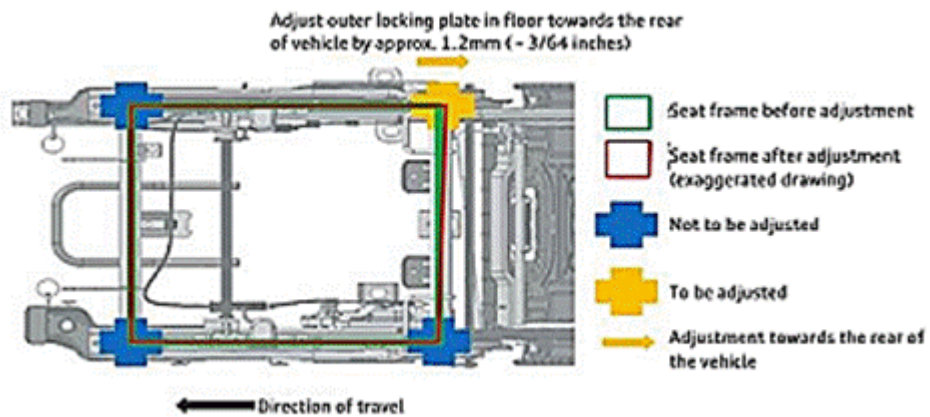
Figure 6. Adjustment of the outer console.
