Technical Service Bulletin

90 Audi pre sense warning, warning jolt, and/or brake engagement (Q3)

90 24 42 2076009/1 November 15, 2024.

Model(s)	Year	VIN Range	Vehicle-Specific Equipment
Q3	2019 – 2025	All	Without Audi Pre Sense

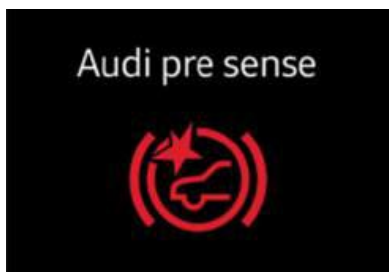
The customer saw the Audi pre sense symbol in the instrument cluster.

Figure 1: Audi pre sense instrument cluster message
