94-22-01 - Taillight Cluster Condensation

Release date: 11/27/2024

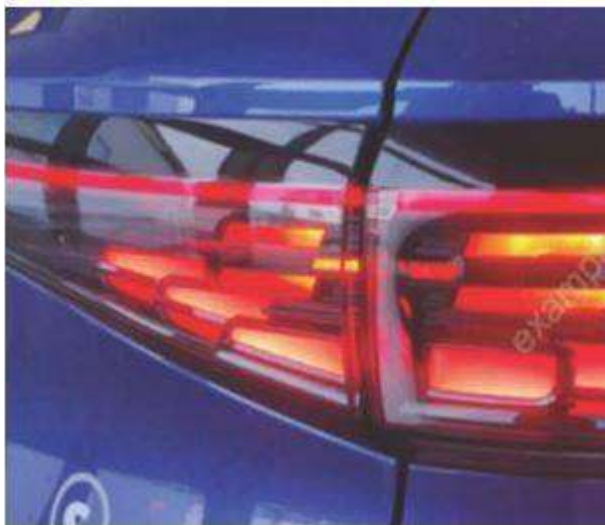
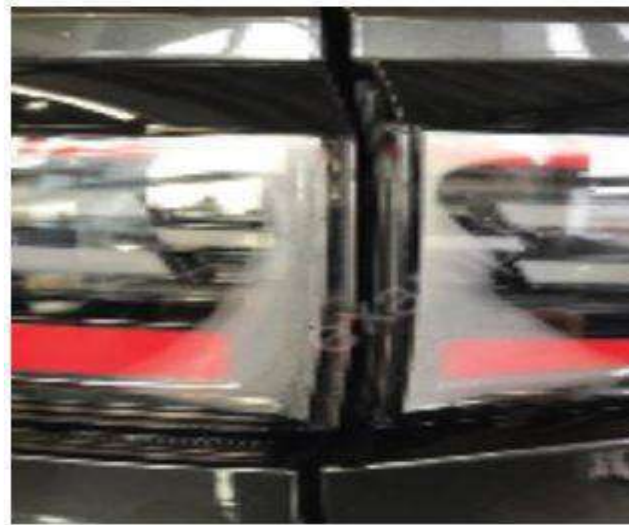
1. Example of taillight with slight condensation, no drips or water droplets.

1. Taillights: the condensation should systematically dry out after a change of the climate conditions.

This condition is normal, no replacement necessary.

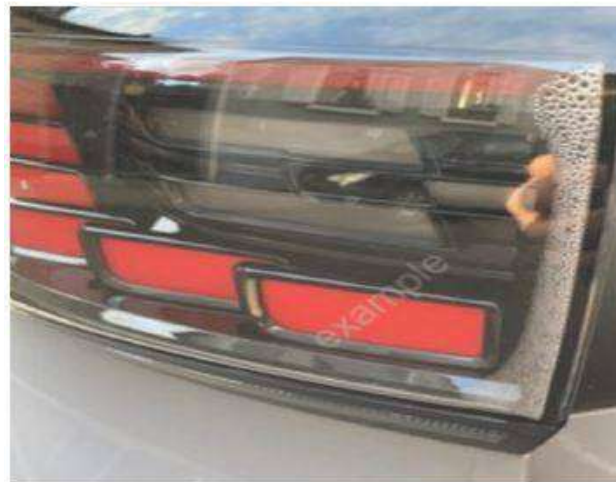
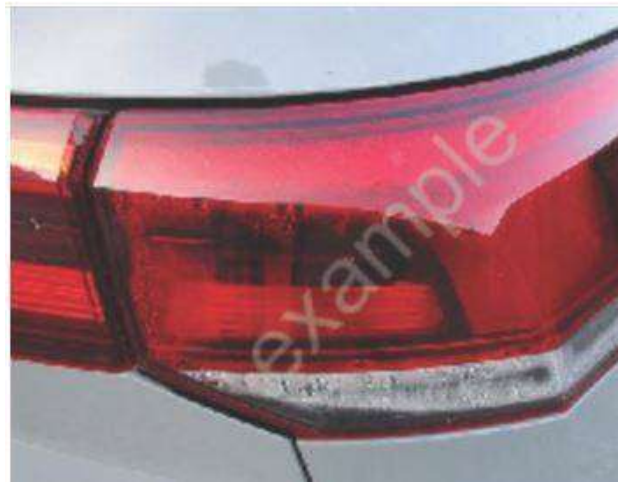
2. Examples of taillight condensation, with droplets or water dripping.

2. In case of an obvious water ingress check the taillight cluster for optical faults (seal fit, taillight housing cracks).
