Technical Bulletin TB247  
11.2024

Item: TB247.1

Description: Instrument Connectivity System Menu Trays

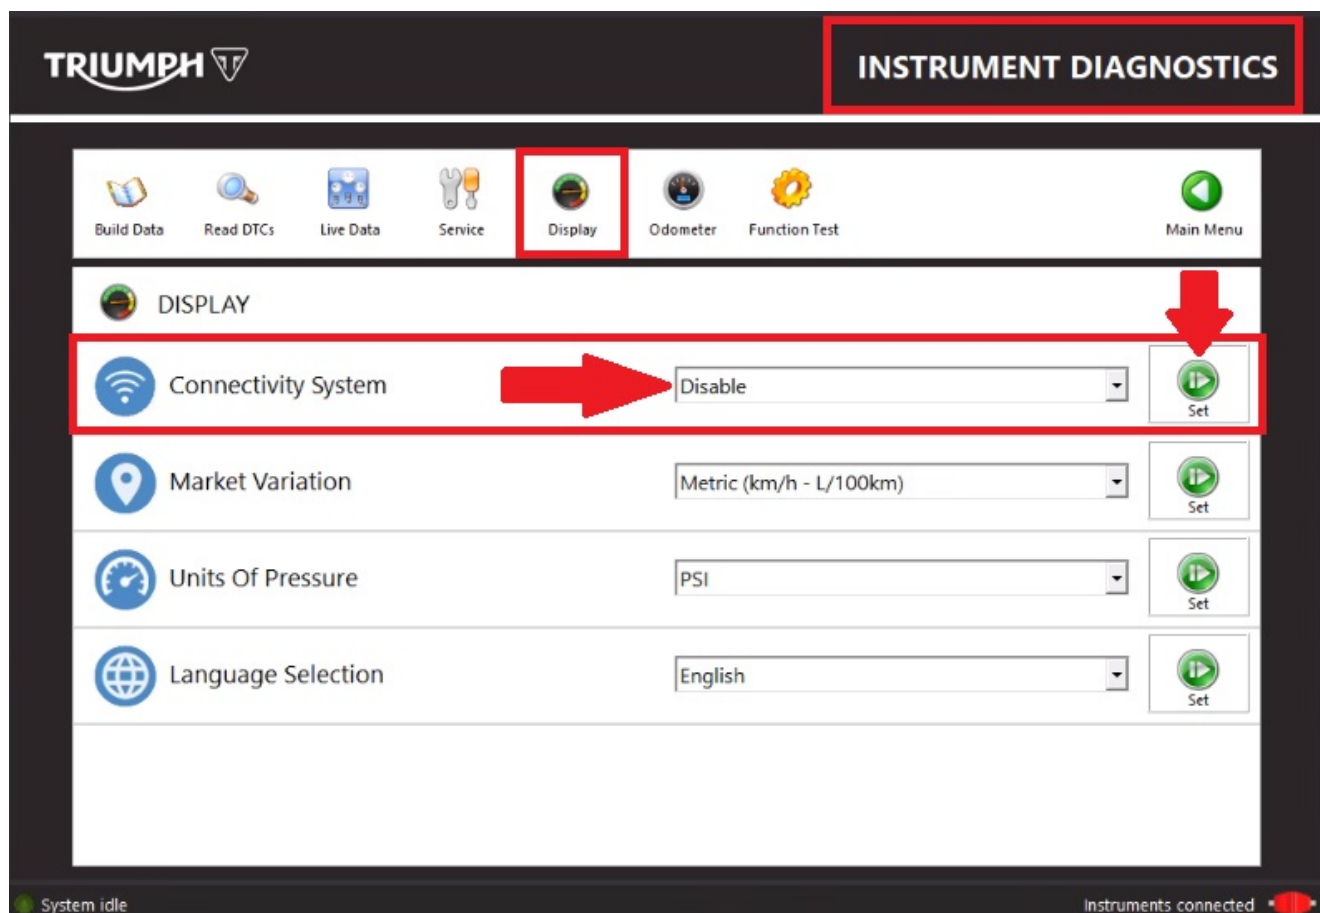
We would like to inform dealers that models in the VIN ranges specified above will be delivered with instrument connectivity menu trays incorrectly enabled.

If the instrument connectivity menu trays are not disabled, they will remain visible to the rider. However, if a My Triumph Connectivity Module is not fitted, the rider will not be able to pair a Bluetooth device or use the connectivity features.

1. Connect the Triumph Diagnostic Tool.
2. Update and unlock the motorcycle as per the normal Pre Delivery Inspection process.
3. From the home screen, navigate to **Diagnostics -> Instruments -> Display**.
4. Select "Disable" from the drop-down box next to the "Connectivity System" label.
5. Click "Set" and wait for the process to complete.

6. Validate the process has completed by cycling through the instrument menus. Connectivity menu trays should no longer be visible.
