STAR ONLINE PUBLICATION

Case Number: S2323000074 Rev. A

Symptom/Vehicle Issue: Buzz Squeak Rattle (BSR) From Sound Bar Or Sport Bar Area.

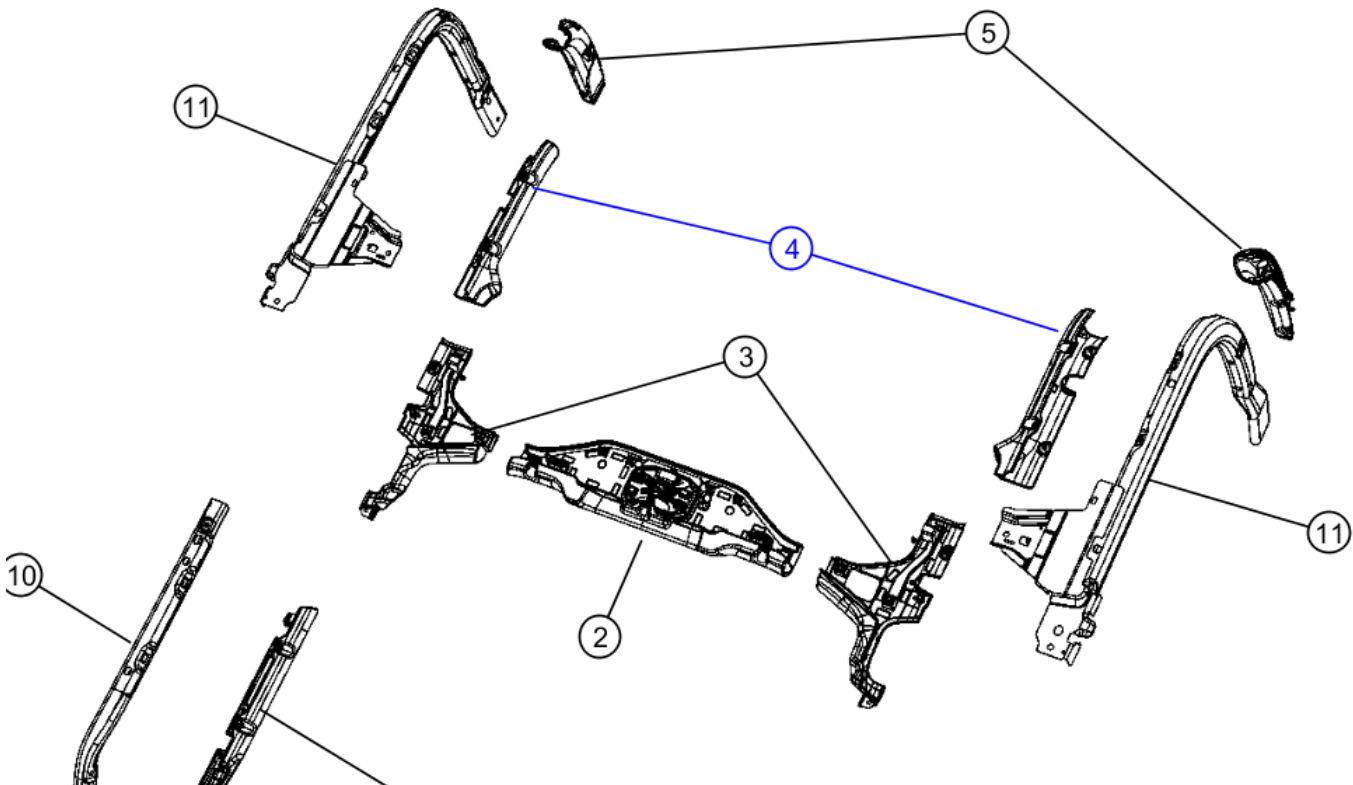
Fig 1.
Sport Bar Trim Item 4.

Customer Complaint/Technician Observation: BSR noise may occur driving on rough roads or with high bass loud music.

Discussion: Using a helper to drive, duplicate the conditions necessary to create the BSR. Press upward on the sport bar trim to isolate the vibration (item 4 in Fig 1 below). If the noise is lessened or resolved with hand pressure, proceed with installing foam as shown below.

Remove the sport bar trim using a T25 torx bit. Review the foam application areas. Using isopropyl alcohol, wipe the area where foam is to be applied to remove grease, oils and dirt that may be present. Apply Mopar foam 68053426AA or 68643986AA on the underside of the sport bar trim as shown in Fig 2. Install foam on both right and left-hand sport bar trim as shown.

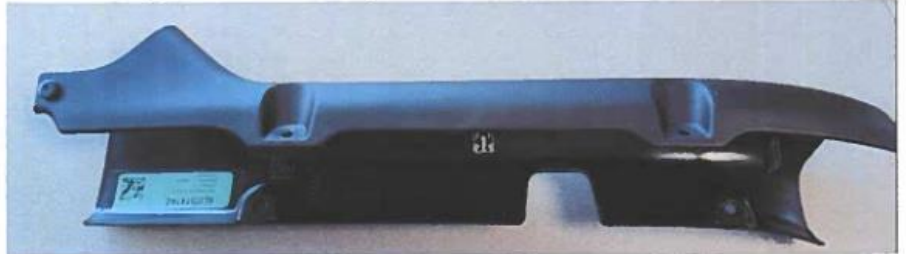
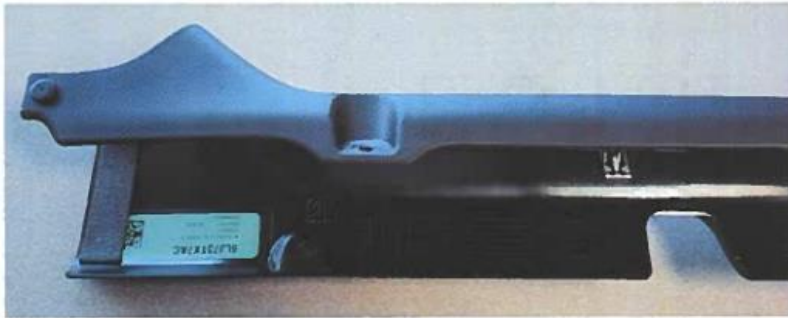
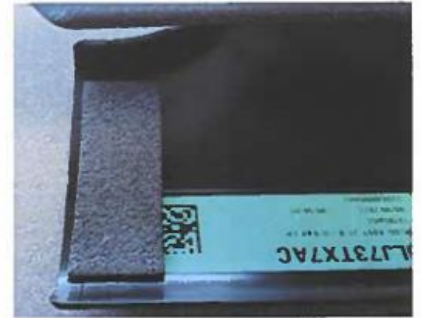
Fig 2.
Sport Bar Trim Removed. Foam application shown.

Foam Material

B-D Mldg/Trim Left and Right equal

Foam placement on part

Close-up but not over edge
