Technical Service Bulletin

SUBJECT:			No: TSB-22-55-002REV4
A/C UNINTENTIONALLY TURNS OFF, REMAINS OFF OR THE TEMPERATURE SETTING CHANGES - REVISED			DATE: November 2024
			MODEL: See below
CIRCULATE TO:	<input type="checkbox"/> GENERAL MANAGER	<input checked="" type="checkbox"/> PARTS MANAGER	<input checked="" type="checkbox"/> TECHNICIAN
<input checked="" type="checkbox"/> SERVICE ADVISOR	<input checked="" type="checkbox"/> SERVICE MANAGER	<input checked="" type="checkbox"/> WARRANTY PROCESSOR	<input type="checkbox"/> SALES MANAGER

This bulletin supersedes TSB-22-55-002REV3 issued April 2024 to update the affected vehicles, background and applicable part numbers (by vehicle). Revisions are italicized and indicated by ◀.

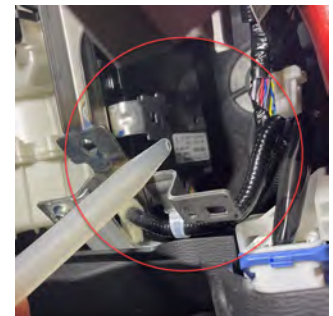
4. AC Auto Amp is on the right hand side of the HVAC Case (fresh air intake) and is held by "1" screw.

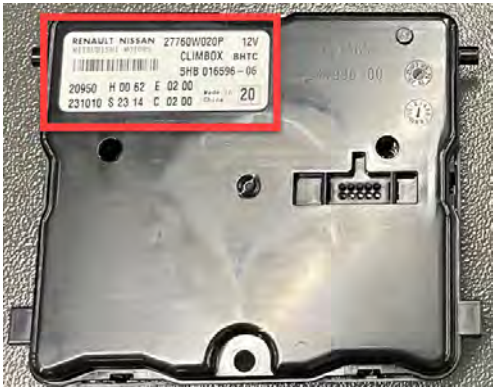
Location of A/C Amp part number.
