## Connect Registration and Pairing PDI Tips – Resolve Blinking Red SOS Light

### Vehicles Affected

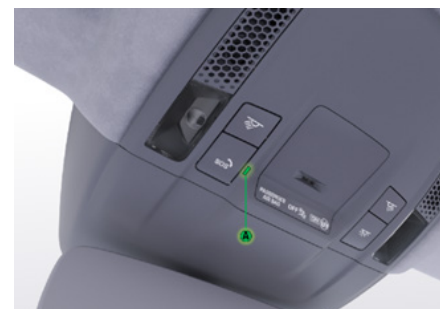
Figure 1

Since the MIB3 system utilizes an eSIM that is not preregistered at the factory, the eSIM must go through a "Registration and Pairing" (R&P) process once Flight Mode is deactivated in the Connect Control Unit (Part ID 9196, also known as the ConBox High or Emergency Call Control Unit). The R&P process, including undisturbed sleep cycles, typically takes 30 minutes or longer. In some cases, this process can take a few hours depending upon signal strength and backend system availability. Once the eSIM completes the R&P process, the SOS light in the overhead console will turn green. (As in Figure 1.)
