Technical product information

Topic	Rear Shock absorber leaking (Left and / or Right)
Market area	Bentley: worldwide (2WBE),China 796 VW Import Comp. Ltd (Vico), Beijing (6796)
Brand	Bentley
Transaction No.	2075810/1
Level	EH
Status	Approval
Release date

New Continental GT - New Continental GTC - New Flying Spur

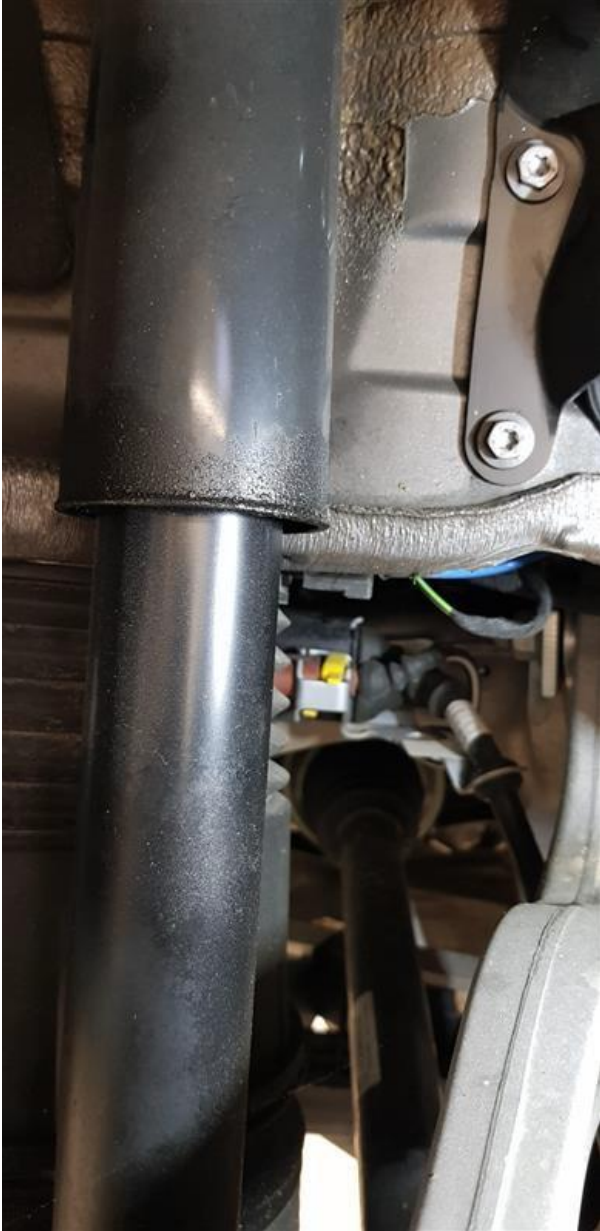
Figure 1

Oil leak evident from the rear shock absorber (Left and / or Right)

Should oil be leaking from the left or right rear shock absorber as shown in Figures 1 - 2 and 3, the operative should refer to the Measure section of this TPI

1) Raise a non-technical DISS query - Attach photos of the leaking shock absorber(s) - Submit the non-technical DISS query - Please continue as follows:

• Replace (x1) rear shock absorber only **UNLESS THE PART NUMBER FOR THE REPLACEMENT SHOCK ABSORBER DOES NOT MATCH THE PART NUMBER OF THE ORIGINAL SHOCK ABSORBER - IN THIS SCENARIO THE OPERATIVE MUST REPLACE BOTH REAR SHOCK ABSORBERS**

• Replace both rear shock absorbers ensuring the part numbers are the same on both sides

2) Conduct wheel alignment (front and rear) and calibration of the applicable driver assist systems (Depending on vehicle specification)
