# Technical product information

<b>Topic</b>	DTC P096C00 and / or P096F00 evident within the Engine Control Module
<b>Market area</b>	Bentley: worldwide (2WBE),China 796 VW Import Comp. Ltd (Vico), Beijing (6796)
<b>Brand</b>	Bentley
<b>Transaction No.</b>	2075941/1
<b>Level</b>	EH
<b>Status</b>	Approval
<b>Release date</b>

DTC P096C00 and / or P096F00 evident within the Engine Control Module

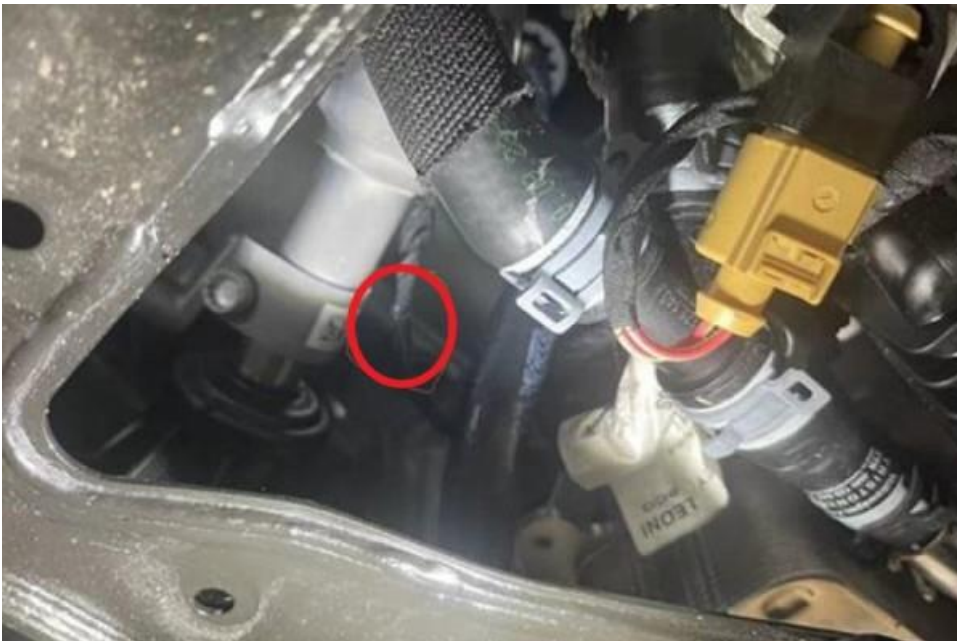
Figure1

- 1) Referring to the applicable wiring diagram - Conduct an electrical integrity check of the N509 gearbox cooling valve circuit
- 2) Referring to Figures 1, 2 and 3 - Conduct a visual inspection to confirm if the harness shown (CIRCLE) has any damage relating to contact with the steering shaft .

In the event the issue is as described the operative must conduct the remaining instructions (step 3 and 4) to completion and repair the damaged cable(s)

- 3) Referring to Rep.Gr 97 - Wiring harness repairs - Repair the damaged wiring using the VAS 1978B wiring repair kit
- 4) Secure the harness as shown in Figure 4
