Technical product information

Topic	Rear Shock absorber leaking (Left and / or Right)
Market area	Bentley: worldwide (2WBE),China 796 VW Import Comp. Ltd (Vico), Beijing (6796)
Brand	Bentley
Transaction No.	2075810/2
Level	EH
Status	Approval
Release date

New Continental GT - New Continental GTC - New Flying Spur

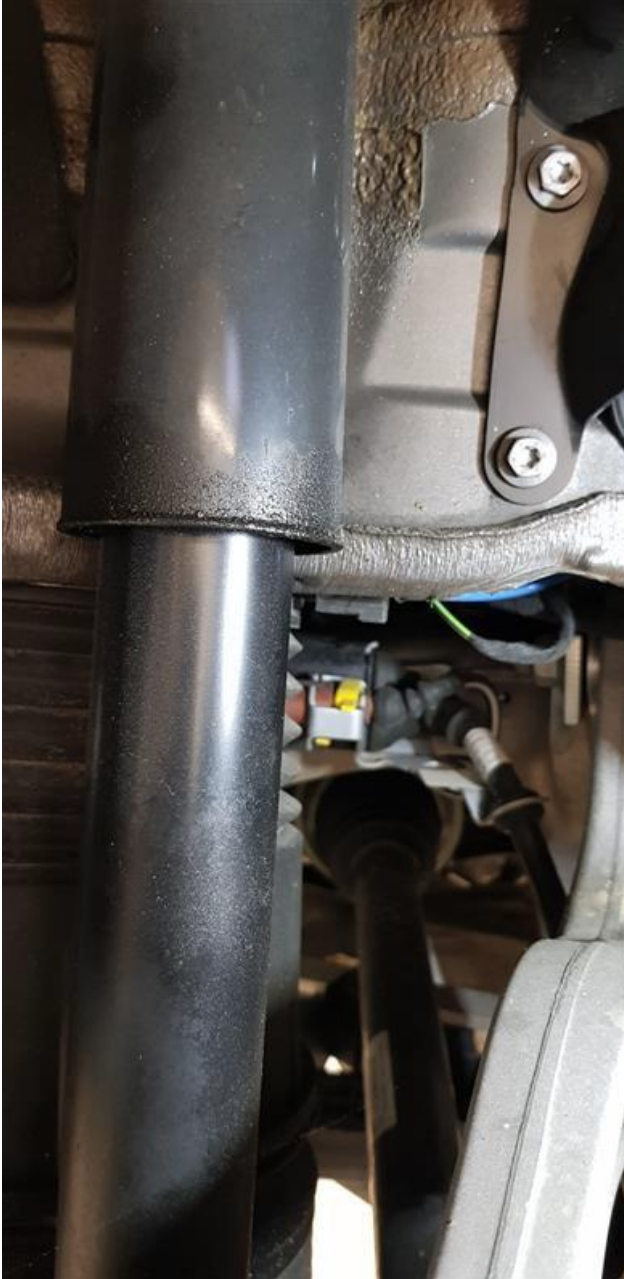
Figure 1

Oil leak evident from the rear shock absorber (Left and / or Right)

Should oil be leaking from the left or right rear shock absorber as shown in Figures 1 - 2 and 3, the operative should refer to the Measure section of this TPI

1) Raise a non-technical DISS query - Attach photos of the leaking shock absorber(s) - Submit the non-technical DISS query - Please continue as follows:

• Replace (x1) rear shock absorber only **UNLESS THE PART NUMBER FOR THE REPLACEMENT SHOCK ABSORBER DOES NOT MATCH THE PART NUMBER OF THE ORIGINAL SHOCK ABSORBER - IN THIS SCENARIO THE OPERATIVE MUST REPLACE BOTH REAR SHOCK ABSORBERS**

• Replace both rear shock absorbers ensuring the part numbers are the same on both sides

2) Conduct wheel alignment (front and rear) and calibration of the applicable driver assist systems (Depending on vehicle specification)
