# McLaren Artura Engine Oil Leak Diagnosis Guide – Oil Pump

**Location:** Powertrain

**Topic:** McLaren Artura Engine Oil Leak Diagnosis Guide - Oil Pump

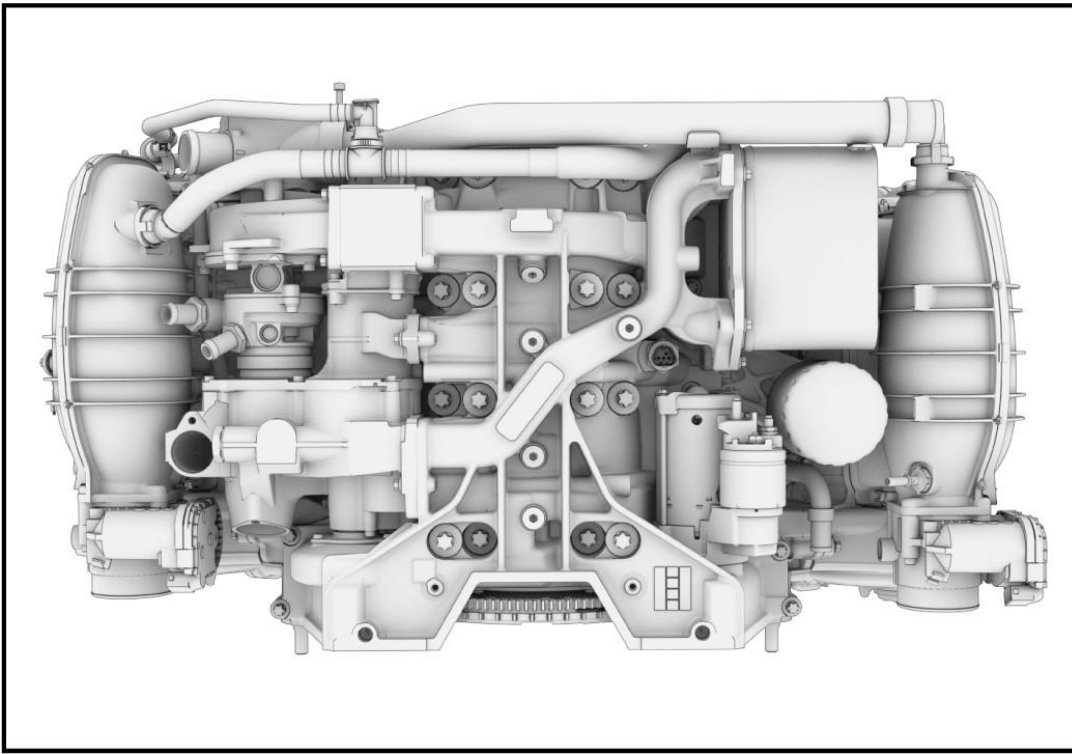
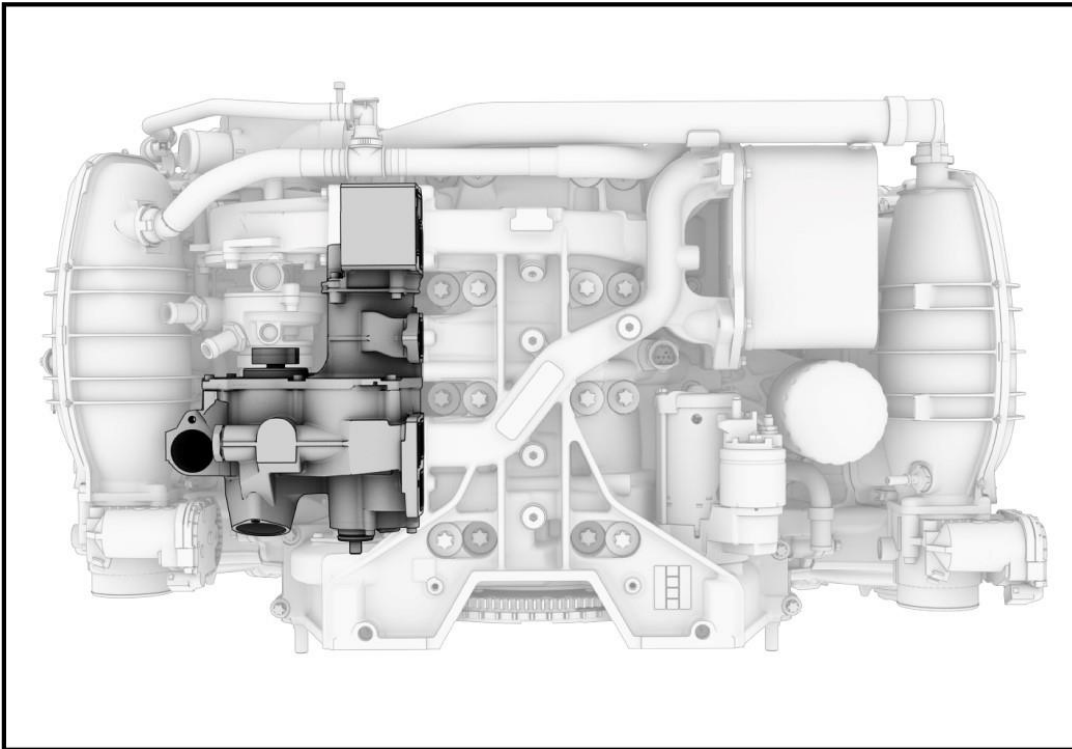
The engine oil pump on the Artura is wet assembled meaning there could be traces of oil on the oil pump when inspecting.

1. Raise vehicle on ramp as per SIS instructions
2. Remove engine underfloor
3. Capture images prior to any cleaning, clearly showing the leaking area. Label images: "Pre-Cleaning"
4. Take picture of engine number and label image "Engine Number"

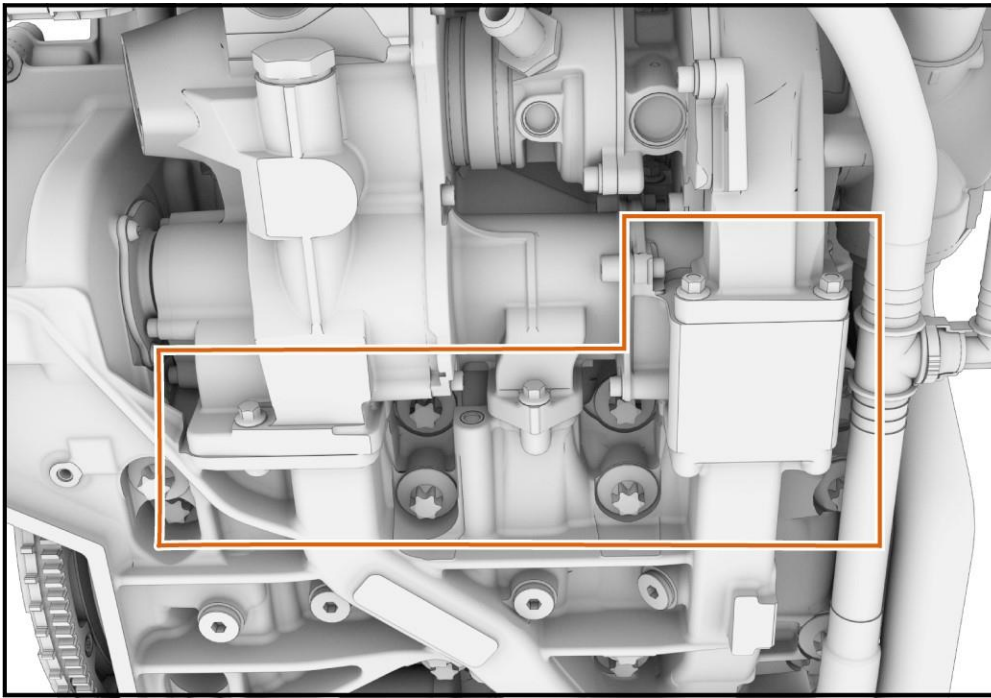
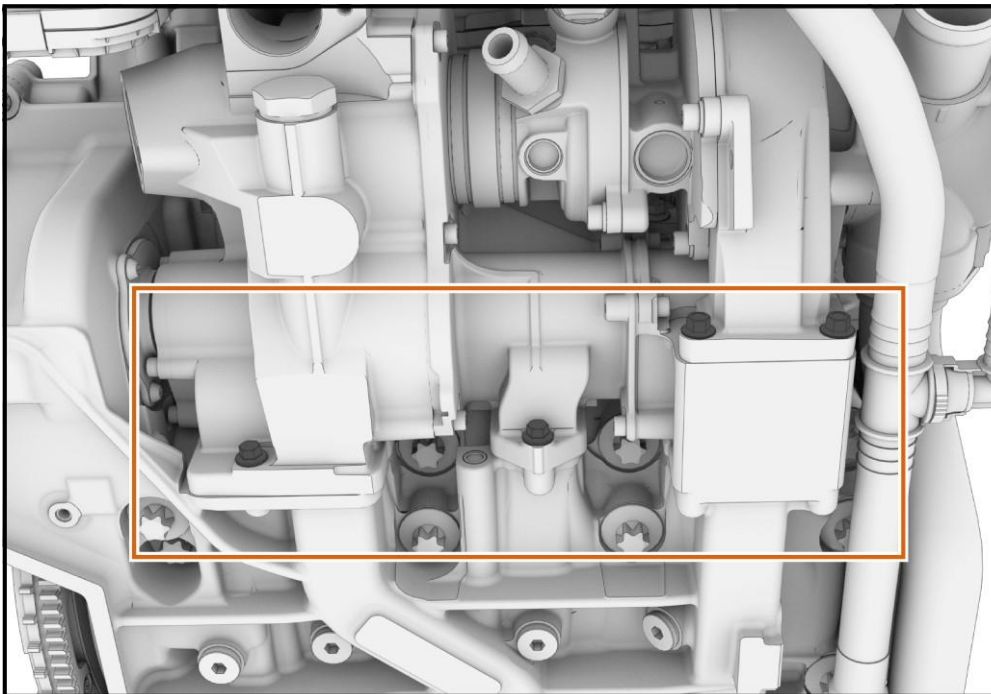
9. Inspect engine. Capture images and label images "Cycle 1", clean area again thoroughly, capture images and label images "Post Cycle 1"

**Care Point: If there is a clear and active leak after step 9, please stop the warm up cycles and submit a TR with supporting images/video**
