JLRTB02130NAS2

TECHNICAL BULLETIN

LOADSPACE COVER HANDLE ASSEMBLY LOOSE

MODEL:	MODEL YEAR:	ASSEMBLY PLANT:
Range Rover (LK)	2022 Onwards	Solihull

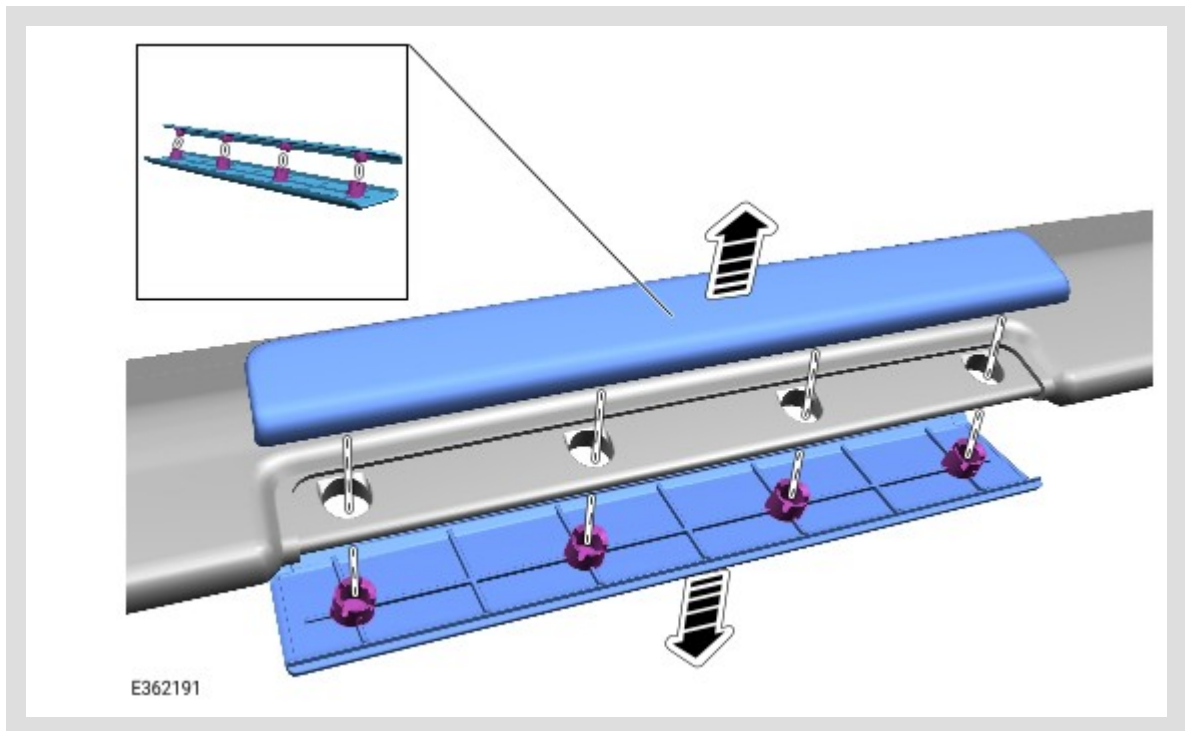
2.

On some occasions during customer use, the rigid loadspace cover handle assembly becomes loose/adrift and the upper and lower sections detach.

Care must be taken not to damage the components, a suitable plastic trim tool must be used to release the clips.

Carefully separate the upper and lower loadspace cover handle assembly.
