# Technical product information

<b>Topic</b>	Front carpets / Mats wet - Musty smell in the cabin - Suspected leak from the water and condensate drains
<b>Market area</b>	Bentley: worldwide (2WBE),China 796 VW Import Comp. Ltd (Vico), Beijing (6796)
<b>Brand</b>	Bentley
<b>Transaction No.</b>	2075697/1
<b>Level</b>	EH
<b>Status</b>	Approval
<b>Release date</b>

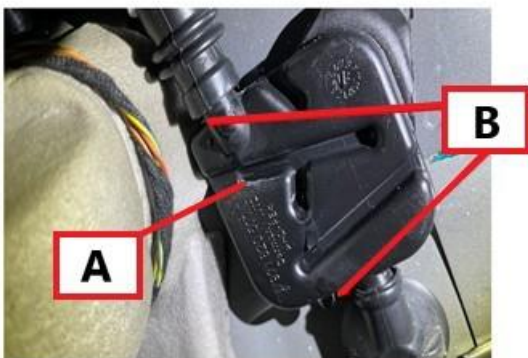
- Allow the engine to idle for 5 minutes
- Referring to Figure 4 - After 5 minutes has elapsed
- Check the left and right hand condensate drains for signs of moisture residue stains (A)
- Check the hoses for signs of water leaks (B)

In the event that water is leaking from the condensate drain hoses at the points shown in Figure 4 or moisture residue stains are evident the operative should conduct the remaining instructions from step 4 on the left and right hand side
