Working on High-Voltage Battery: Additional Photo Documentation Required when Removing the High-Voltage Battery (194/24)

Model Line: **Taycan (Y1A / Y1B / Y1C)**

Concerns: **High-voltage battery**

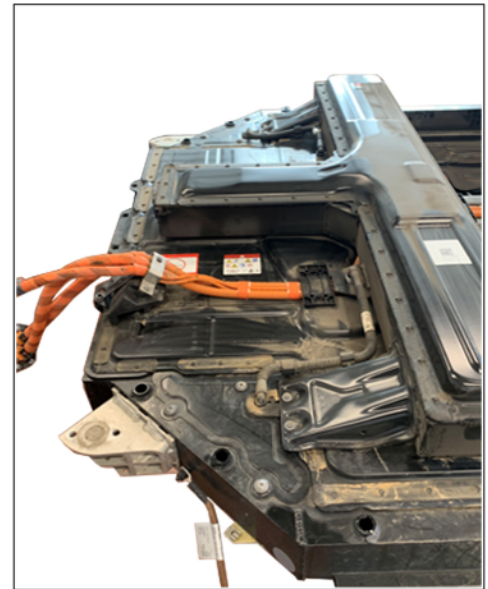
Overview of frame corner (sample representation at rear right frame corner)

- 3 Photograph the frame at **all four corners** in the following views.

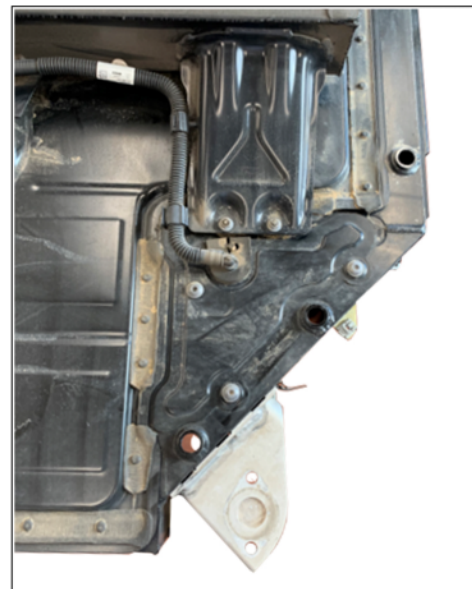
Top view of frame corner (sample representation at rear right frame corner)

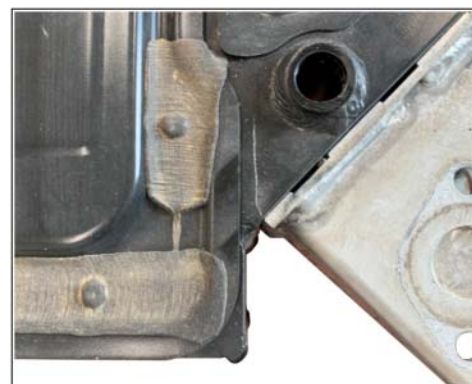
Top view of weld seams (sample representation at rear right frame corner)

- 4 Photograph weld seams at **all four frame corners** in the following views.

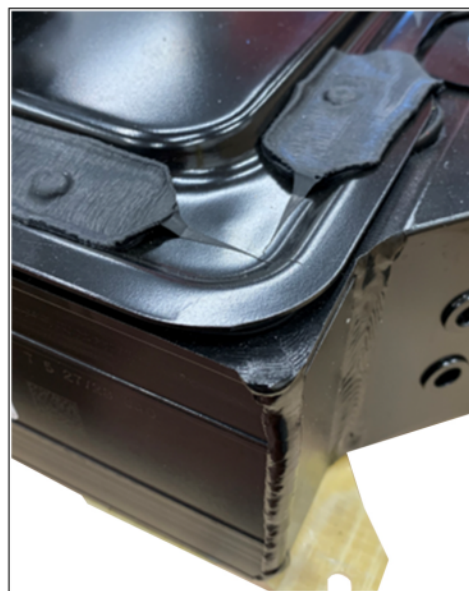
Detailed view of welded seams (sample representation at rear right frame corner)

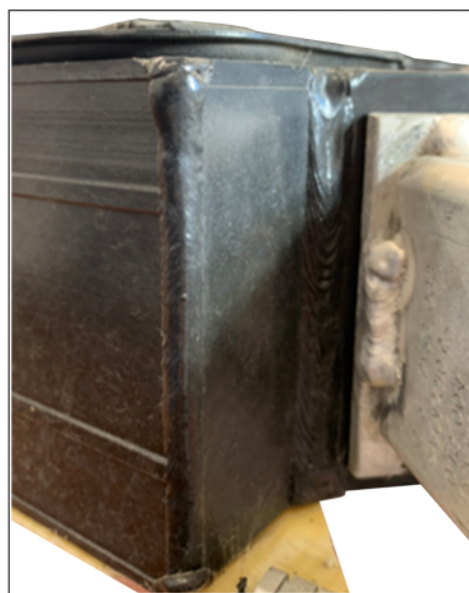
Side view of weld seams (sample representation at rear right frame corner)

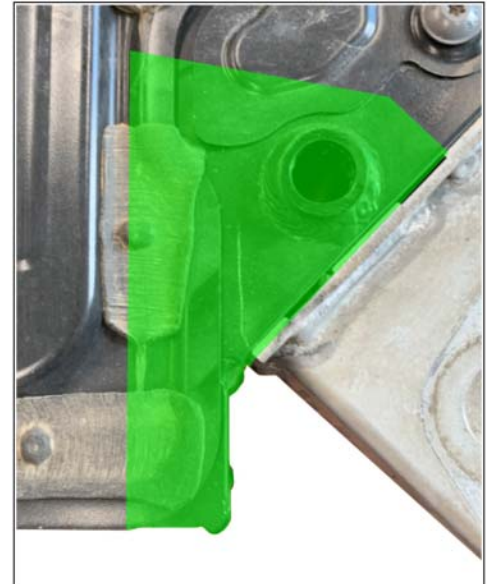
Top view of cleaned weld seams (representation of cleaned surface in green)

- 5 Clean the high-voltage battery with a cleaning cloth and isopropanol at **all four frame corners** and photograph it in the following views.

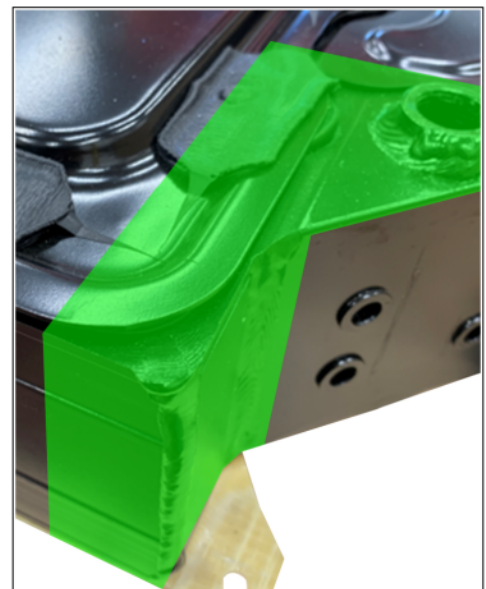
Detailed view of cleaned weld seams (representation of cleaned area in green)

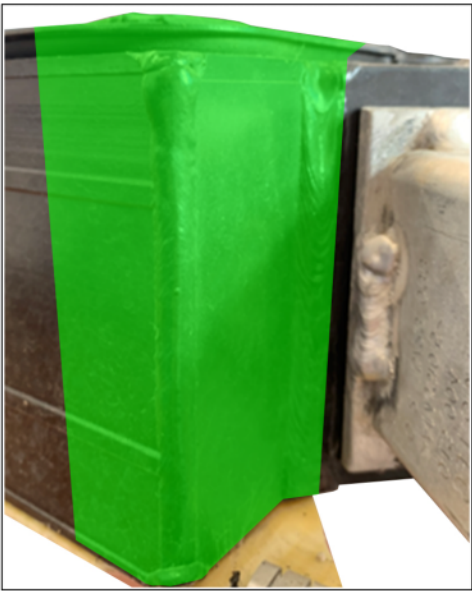
Side view of cleaned weld seams (representation of cleaned surface in green)
