GENERAL MOTORS
DCS7094
URGENT - DISTRIBUTE IMMEDIATELY

Subject: N242473580 - Customer Satisfaction Program
Misassembled Transmission Shaft Seal

Models: 2025 Buick Enclave
2024 - 2025 Chevrolet Traverse
2024 GMC Acadia

N242473580 Misassembled Transmission Shaft Seal

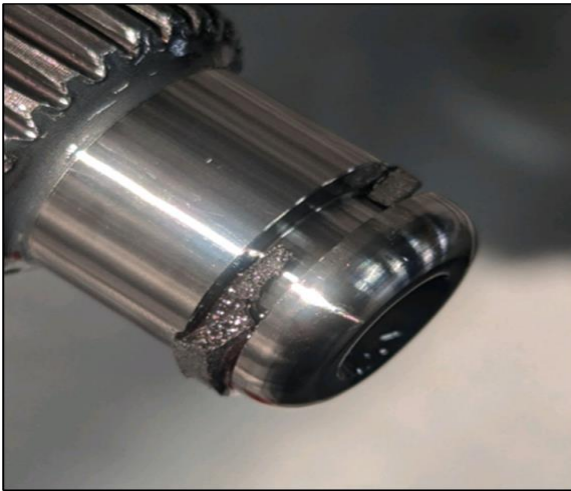
6782733

2. Inspect the Turbine Shaft Seal for a damaged or missing condition similar to the picture above.
3. If the Turbine Shaft Seal is damaged or missing, the Torque Converter **MUST** be replaced. If the original seal is intact, replace the Turbine Shaft Seal **ONLY**, following the procedure below.
4. Remove the Turbine Shaft Seal and clean any debris from the seal groove.

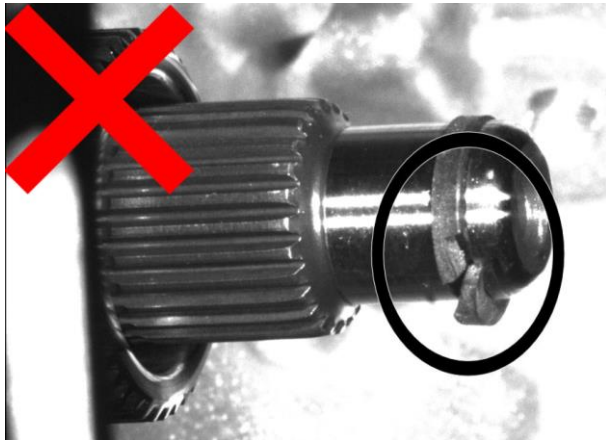
6782729

Caution: DO NOT overstretch the turbine shaft seal during installation. A properly installed seal will appear centered in the turbine shaft groove with very little gap at the seal expansion joint. Failure to install the seal correctly may result in deformation of the seal and internal transmission damage.

5. Press a NEW Turbine Shaft Seal onto the turbine shaft. Ensure that the z lock groove is interlocked and aligned as shown in the image above. If the seal is not properly aligned, it will break when the Torque Converter is installed.
6. Install the Torque Converter. A NEW Torque Converter must be installed if the original seal was damaged or missing. Refer to *Torque Converter Installation* in SI.
7. Install the Transmission. Refer to *Automatic Transmission Removal and Installation* in SI.
8. Fill the transmission to the proper level with NEW transmission fluid. Refer to *Transmission Fluid Drain and Fill* in SI.
9. If the Turbine Shaft Seal and Torque Converter were replaced, perform the transmission service fast learn. Refer to *Transmission Service Fast Learn Procedure* in SI.
