Technical Service Bulletin (TSB)
Water Infiltration From Door Liner

REFERENCE:	TSB: 23-057-24 GROUP: 23 - Body	Date:	December 4, 2024	REVISION:	-
VEHICLES AFFECTED:	2024 (FG) FIAT 500e This bulletin applies to vehicles built on or after June 25, 2024 (MDH 0625XX) and on or before August 25, 2024 (MDH 0825XX).			MARKET APPLICABILITY:	
				<input checked="" type="checkbox"/> NA	<input checked="" type="checkbox"/> MEA
				<input checked="" type="checkbox"/> SA	<input checked="" type="checkbox"/> IAP
				<input checked="" type="checkbox"/> EE	<input type="checkbox"/> CH
CUSTOMER SYMPTOM:	Customers may experience the following: <ul style="list-style-type: none"> • Passenger side kick plate and/or front carpet wet. 				
CAUSE:	Door liner damaged during assembly

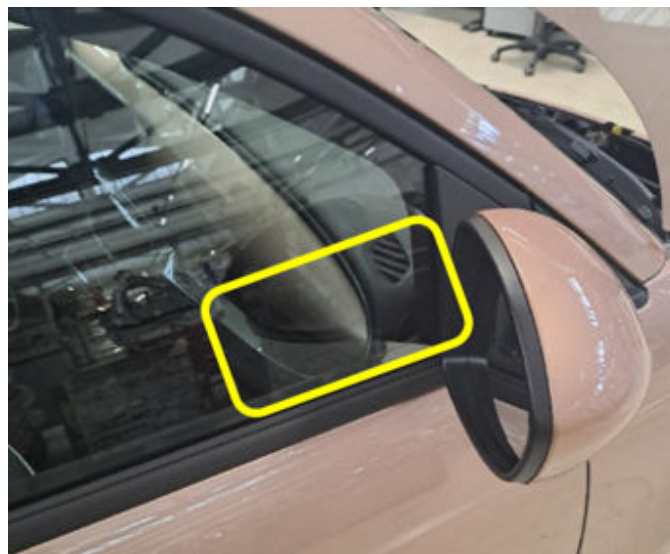
1. With the window rolled all the way up and door completely closed, apply a water stream to the selected area in [Fig. 1](#) for five minutes.

Fig. 1
Area To Water Test
