Technical Journal

HLCM Replacement

REF NO: TJ 37143.3.0	ISSUING DEPARTMENT: Technical Service	CAR MARKET: United States and Canada	
PARTNER: 3 US 7515 Polestar		ISSUE DATE: 2024-11-14	STATUS DATE: 2024-11-18
FUNC GROUP: 3229	FUNC DESC: Miscellaneous	Page 1 of 5

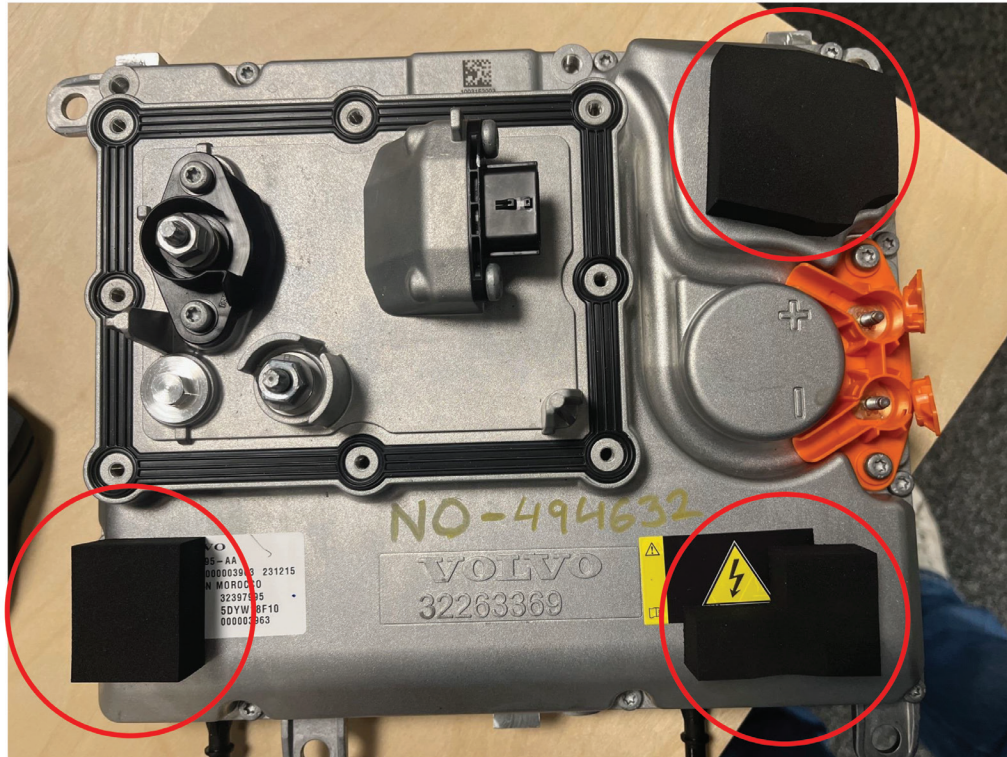
TJ 37143

After the HLCM has been replaced and before the lid is reinstalled, it is important to reuse the three soft dampers shown in the picture (TJ 37143_1.pdf). Move the soft damper from the replaced HLCM to the new one according to the picture.

If needed, use double-sided tape to fasten the soft damper.

Note: Be very careful not to damage the soft dampers.
