## Volvo Car USA LLC

## Technical Journal

Technical Journal Title Vehicle unresponsive		Ref. No. TJ 37145.1.0	
Issuer (Dept.) Technical Service		Issue Date 11/13/24	Status Date 11/26/24
Car Market United States and Canada	Partner 3 US 7510 Volvo Car USA	Function Group 8344	
Function Description Handle, outer for side door		Page Page 1 of 3

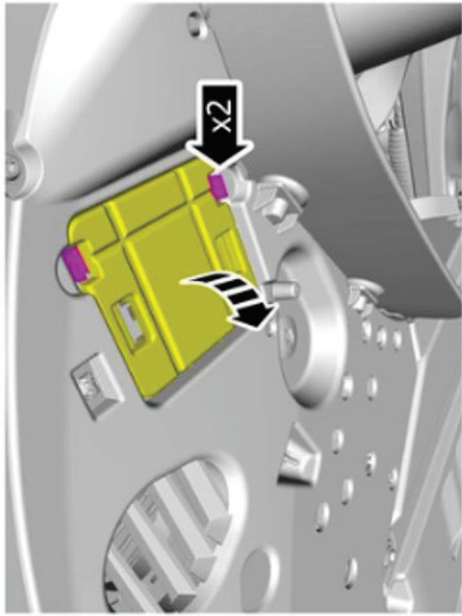
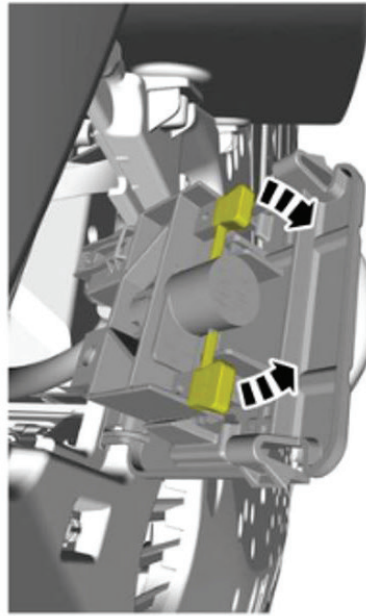
TJ 37145

- If step 1 does not work, try unlocking the car through the Volvo app on the cell phone.
- If step 2 does not work, measure the 12V battery. This is to be done by accessing the external point under the front bumper (See attachment TJ\_37145\_1.JPG). Not on the battery.  
If it's below 8V, cancel the steps and charge the battery according to VIDA. First perform the Emergency Opening steps in VIDA to get access to the vehicle: *Information > General Information > 3 Electrical System > 300 General > Emergency Opening*  
*For charging the battery follow these steps in VIDA: Information > Cleaning, Inspection & Adjustment > 311 Battery > Battery, charging*  
If it's 12V, proceed to the next step.
