REFERENCE:	TSB: 23-058-24 GROUP: 23 - Body	Date:	December 6, 2024	REVISION:	-
VEHICLES AFFECTED:	2025 (M1) Compass (Brazil) 2025 (N4) RAM Rampage 2025 (B1) Jeep Renegade <ul style="list-style-type: none"> This bulletin applies to M1 vehicles built on January 18, 2024 (MDH 0118XX) equipped with the 1.3L I4 Turbo MAIR DI Engine W/ESS E100 (Sales Code EYJ). This bulletin applies to N4 vehicles built on March 21, 2024 (MDH 0321XX) equipped with the 2.0L I4 DOHC DI Turbo Engine W/ESS (Sales Code EC1). This bulletin applies to B1 vehicles built on and after January 24, 2024 (MDH 0124XX) and on and before February 22, 2024 (MDH 0222XX) equipped with the 1.3L I4 Turbo MAIR DI Engine W/ESS E100 (Sales Code EYJ). 			MARKET APPLICABILITY:	
				<input type="checkbox"/> NA	<input type="checkbox"/> MEA
				<input checked="" type="checkbox"/> SA	<input type="checkbox"/> IAP
				<input type="checkbox"/> EE	<input type="checkbox"/> CH

CUSTOMER SYMPTOM:	Customers may experience the following: <ul style="list-style-type: none"> Loose seatback on passenger front seat. 				
CAUSE:	Improper Torque applied

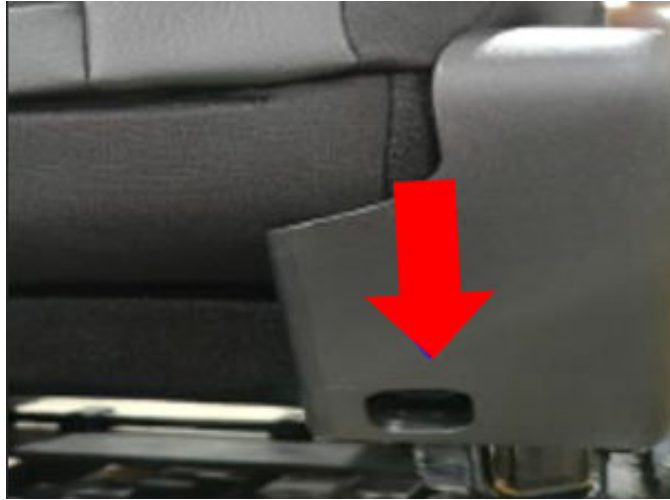
**Fig. 1**

Cover Fastener Location

1. Disconnect the battery negative.
2. Remove the passenger seat. Refer to the detailed service procedures listed in DealerCONNECT>Service Library> under: 7045A10 - Banco dianteiro (um) - esq. ou dir. - remocao/recolocacao.
3. Remove the fastener on the outer back of the plastic cover [Fig. 1](#).

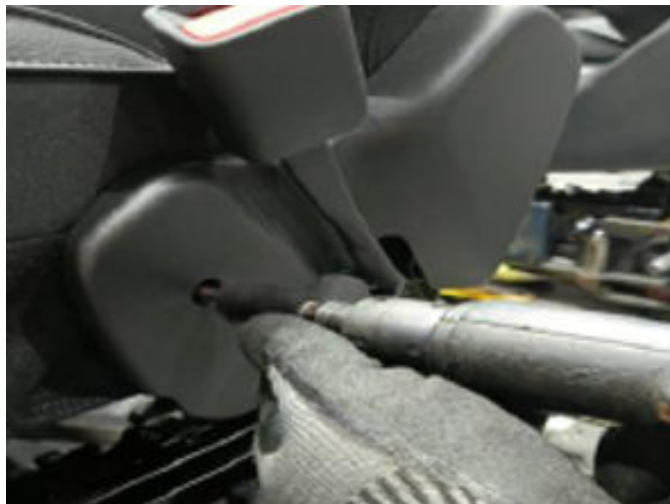
**Fig. 2**

Cover Fastener Location

4. Remove the other fastener and remove the cover from the rear inner guide of the front seat [Fig. 2](#).
