STAR ONLINE PUBLICATION

Case Number: S2403000004 REV. A

Symptom/Vehicle Issue: Tapping, Knocking Type Noise/Vibration While Driving.

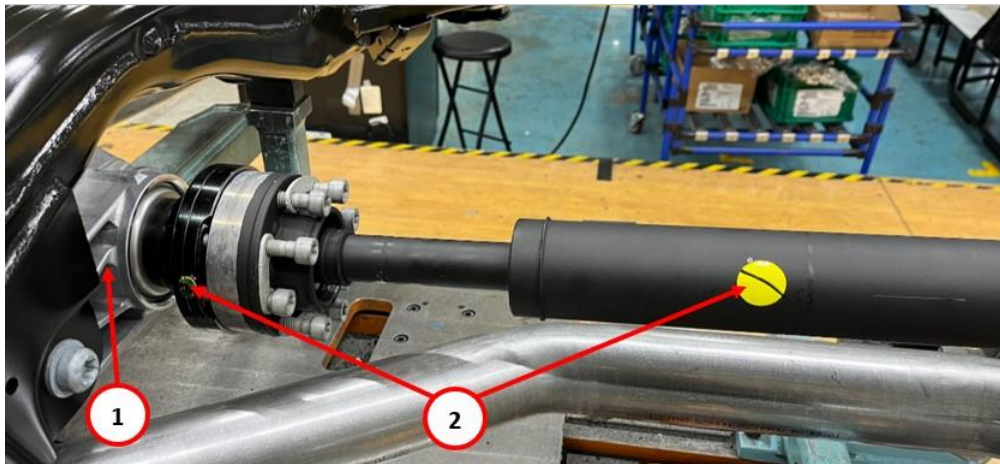
Figure1

4. Verify that the yellow alignment mark on the rear section of the driveshaft aligns with the RDU driveshaft flange. Please see (Figure 1). Were the alignment marks properly aligned?

- a. Yes>>> Go to [step 4](#).
 - b. No>>> Remove the driveshaft to RDU flange bolts in accordance with published service procedures in Service Library and align the marks before reinstalling. Proceed to [step 4](#).
5. Verify that the yellow alignment mark on the front section of the driveshaft align with the Transfer Case driveshaft flange. Please see (Figure 2). Were the alignment marks properly aligned?
