TSB #202001

# Vanderhall

Product Improvement Program (PIP)

Front lower control arm bumpstop retrofit.

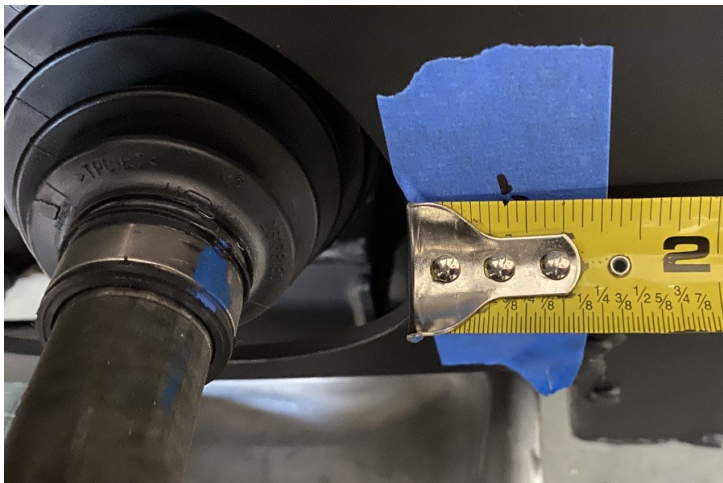
Concerns: This "PIP" is being implemented to avoid any damage to the lower control arms and to avoid any interaction with the lower control arms and the lower frame. This is an attempt to control the components in the event of an extreme suspension compression.

1. Apply masking tape to the frame in front of the cv axle pass through opening, and mark a line vertically  $\frac{5}{8}$  in in front of the cv opening.
