STAR ONLINE PUBLICATION

Case Number: S2424000013

Release Date: December 2024

Symptom/Vehicle Issue: Customer Indicates The Air Flow Through Rear 2nd Row Overhead Vents Are Low.

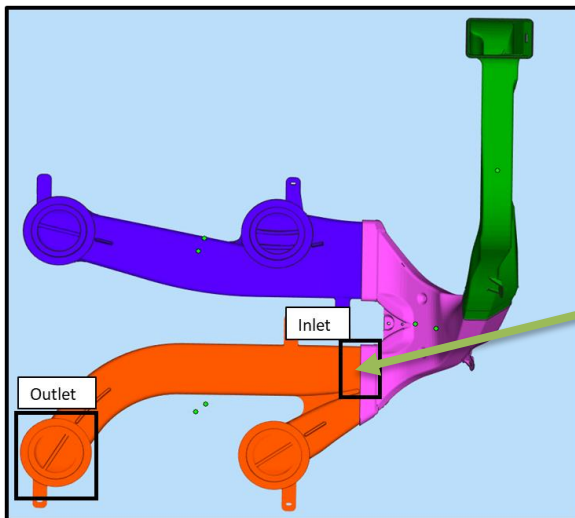
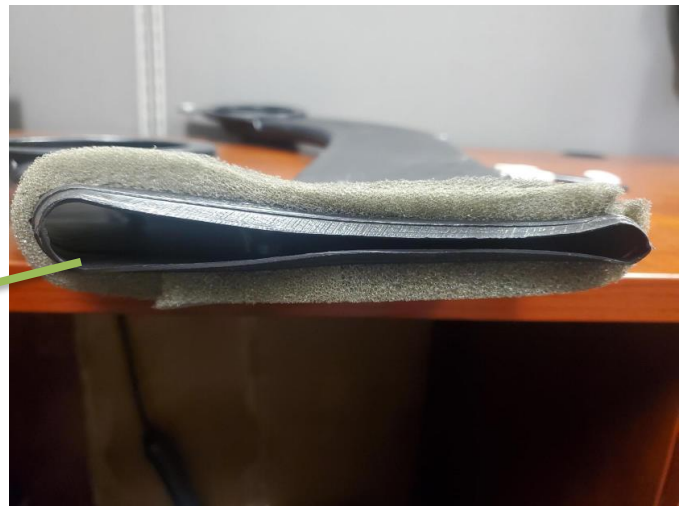
Complaint/Technician Observation: A known issue has shown that the 2nd row driver side overhead duct at the inlet is collapsed creating restricted airflow to outlet and vents. Lower the headliner, inspect for this condition. If found remove duct and replace.
