# Service Bulletin

Bulletin No.: 24-NA-249  
Date: November, 2024

**Subject:** Front Seat Covers Not Secured to Seat Frame

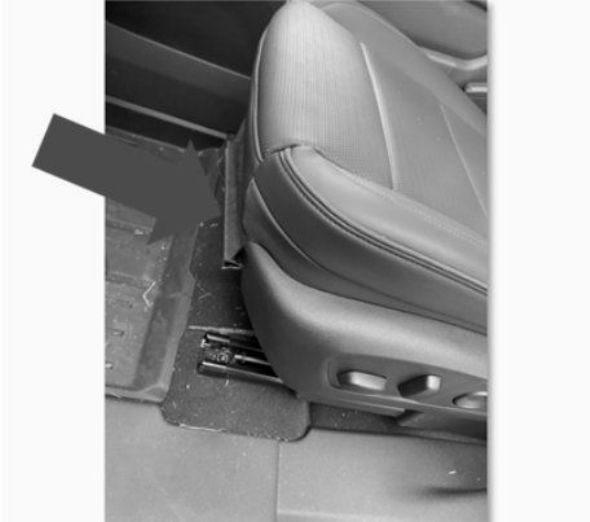
| Condition | <div></div> <div>Some customers may comment that the front lower seat cushion cover is loose at the seat frame. 6760538</div> |
| Cause | The cause of the condition may be the seat frame rolled edge gap might not be the correct width which will impact the retention of the seat cover retainer. |

| Correction | Technicians are to perform the following procedure as described below. |
