**HYUNDAI**  
**Technical Service Bulletin**

GROUP <b>BODY ELECTRICAL</b>	NUMBER <b>24-BE-018H</b>
DATE <b>DECEMBER 2024</b>	MODEL(S) <b>VENUE (QX)</b>

**SUBJECT:** HORN ASSEMBLY REPLACEMENT  
 WARRANTY EXTENSION (TXXU)

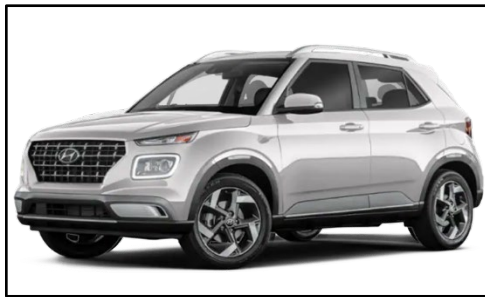
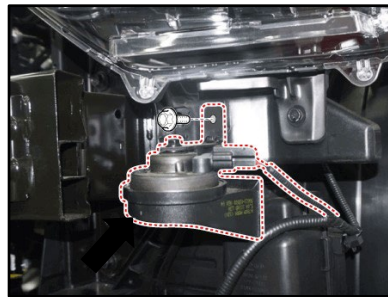
**Description:** Certain 2020-22MY Venue (QX) vehicles may experience an inoperable horn that may be caused by foreign substances causing internal parts to oxidize.

This bulletin provides information on how to fix the inoperative horn.
