Technical Service Bulletin

GROUP BODY	NUMBER 24-BD-012H-1
DATE DECEMBER 2024	MODEL(S) IONIQ 5 (NE EV) IONIQ 5 N (NE EV N)

SUBJECT: TAILGATE RATTLE & FRICTION NOISE REWORK

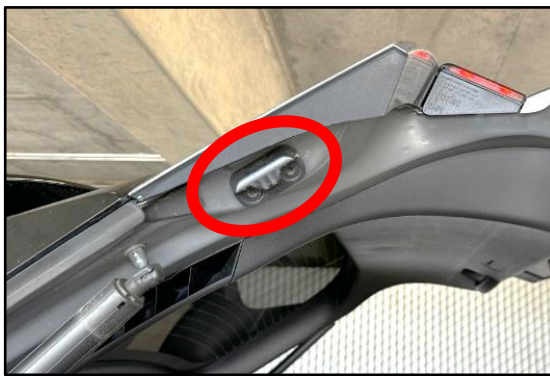
Tailgate Side Panel

Description: Certain IONIQ 5 (NE EV) and IONIQ 5 N (NE EV N) vehicles may exhibit rattle and friction noises from the tailgate while driving. This bulletin provides instructions to adjust the gap between the tailgate and vehicle body to eliminate the rattle and friction noise.
