Service Bulletin

Bulletin No.: 18-NA-210

Subject: High Pitch Whine Noise Coming from Front Instrument Panel (IP) Speakers

Brand:	Model:	Model Year:		VIN:		Engine:	Transmission:
		from	to	from	to		
Chevrolet	Equinox	2018	2024	—	—	—	—
GMC	Terrain

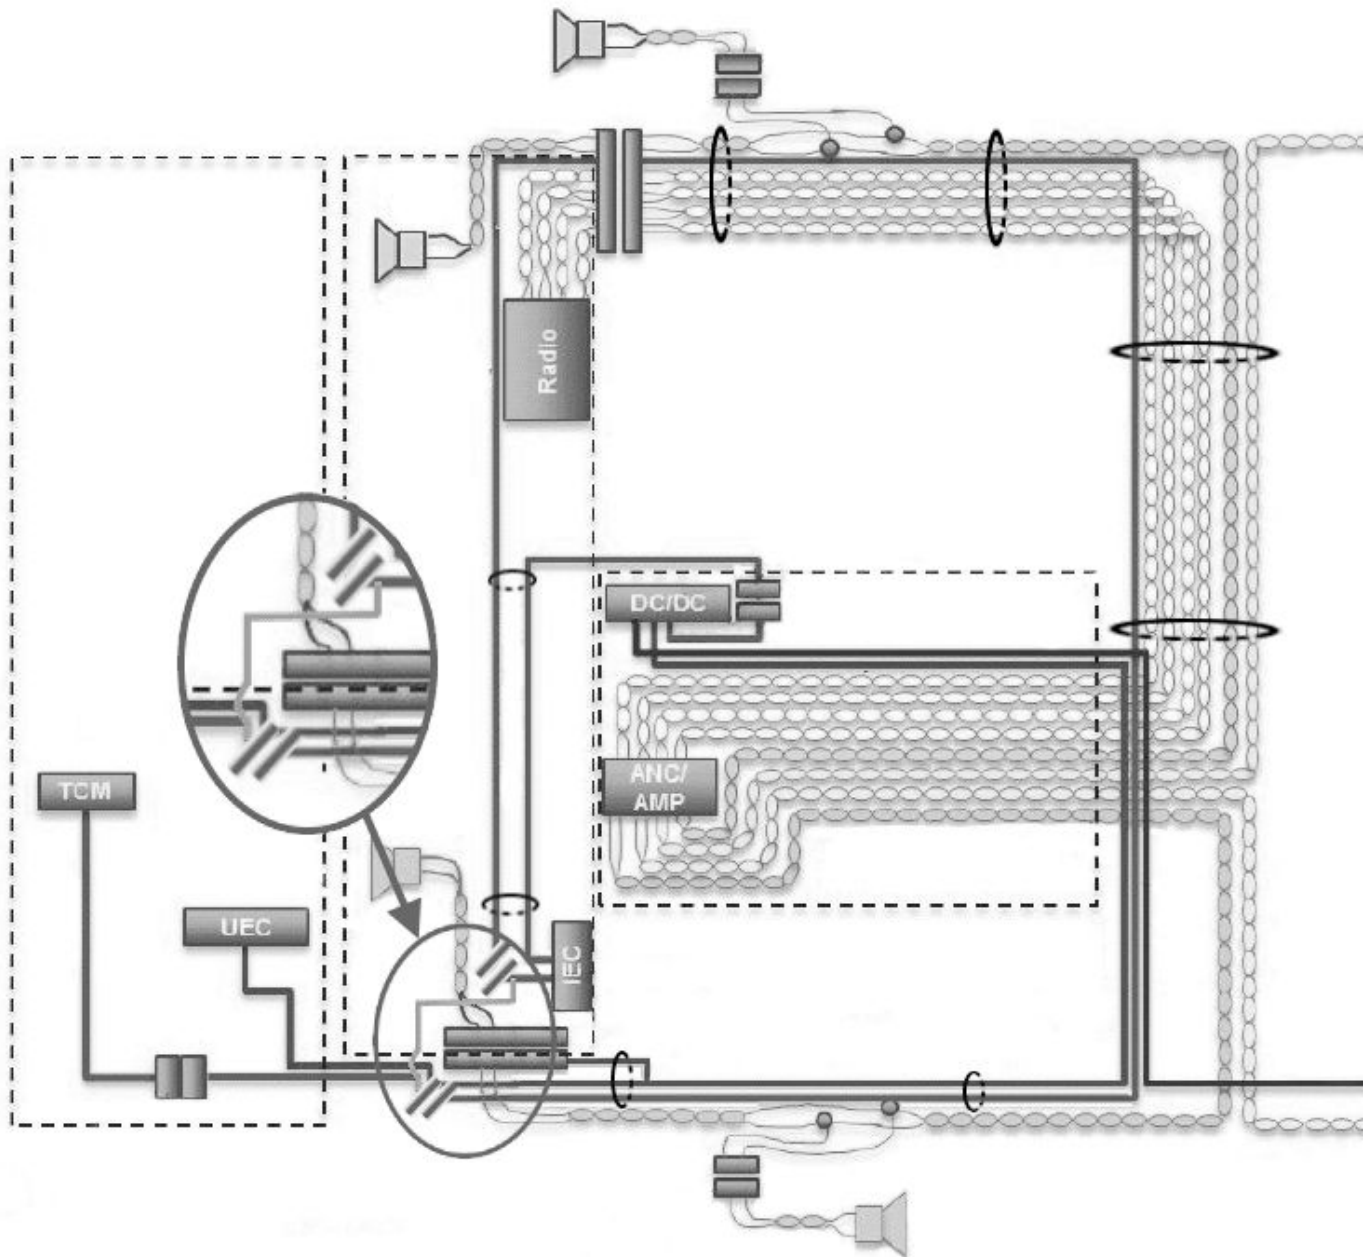
5112945

Important: Performing this repair will eliminate the 2173 circuit wire from the IP wiring harness and bypass it directly to the body side harness, as shown in green in the schematic above.
