Service Bulletin

Bulletin No.: 21-NA-290

Subject: Wrinkle or Bubble in Stripe or Hood Wrap forming Around Outer Edges of Hood Air Scoop

Brand:	Model:	Model Year:		VIN:		Engine:	Transmission:
		from	to	from	to		
Chevrolet	Camaro	2019	2024	—	—	—	—

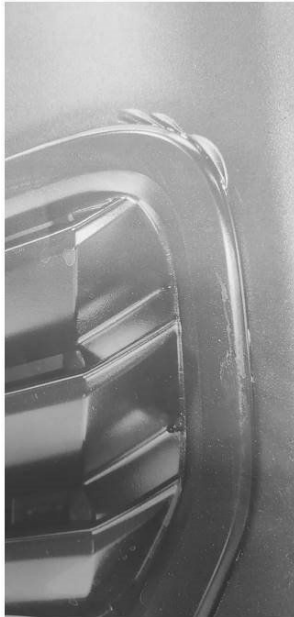
<p style="text-align: right;">5937945</p> <p>Some customers may comment on a wrinkle or bubble in the stripe or hood wrap forming around the outer edges of the hood air scoop.</p>
Cause	This condition may be caused by edges on the bottom of the hood air scoop pressing deep into the stripe or hood wrap, causing air pockets to form over time.
Correction	If you encounter a vehicle with the above concern, refer to the Service Procedure below.
