Service Bulletin

Bulletin No.: 24-NA-113

Subject: Vehicle Wide Programming Instructions

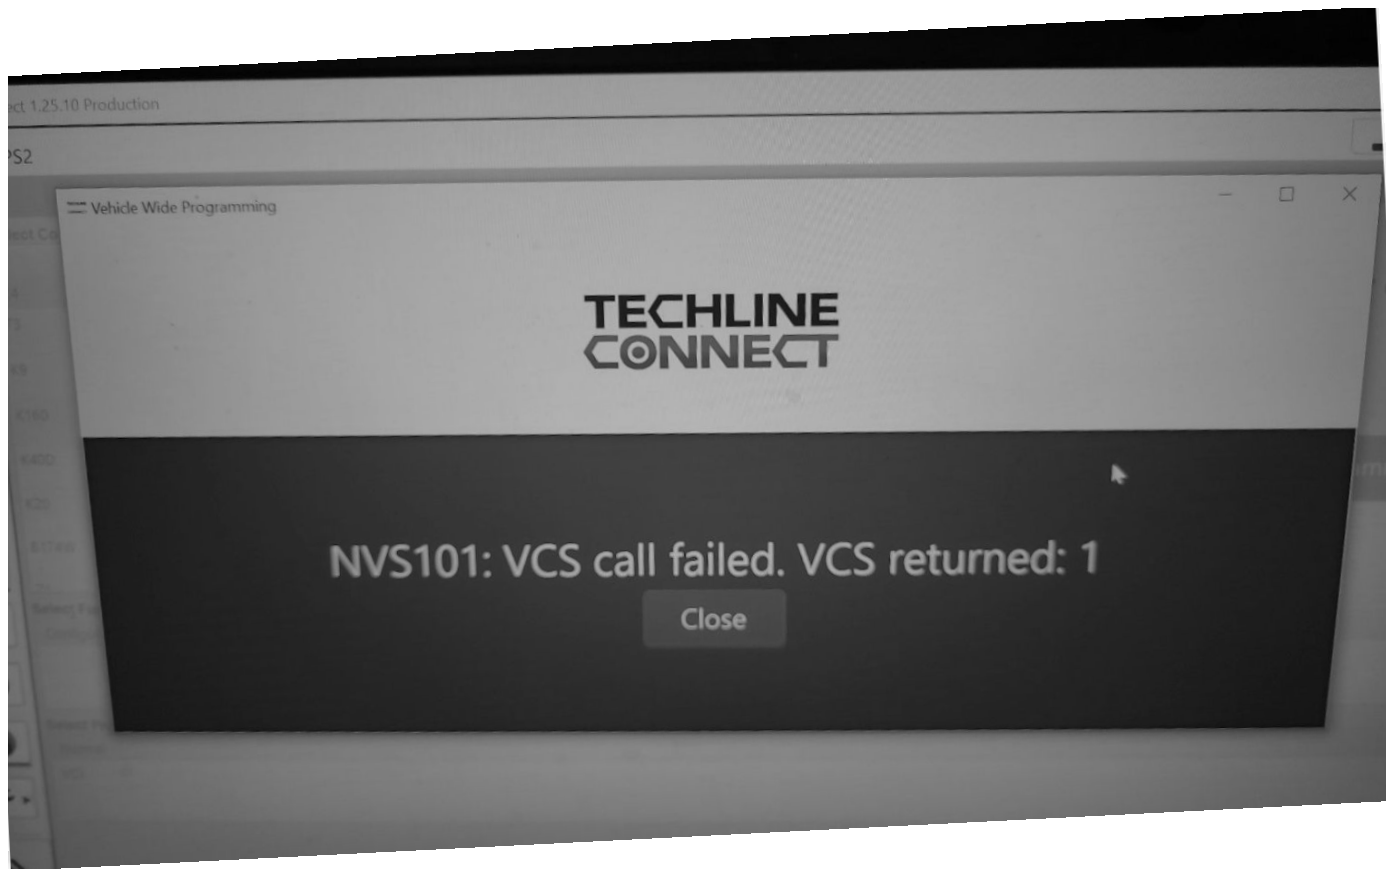
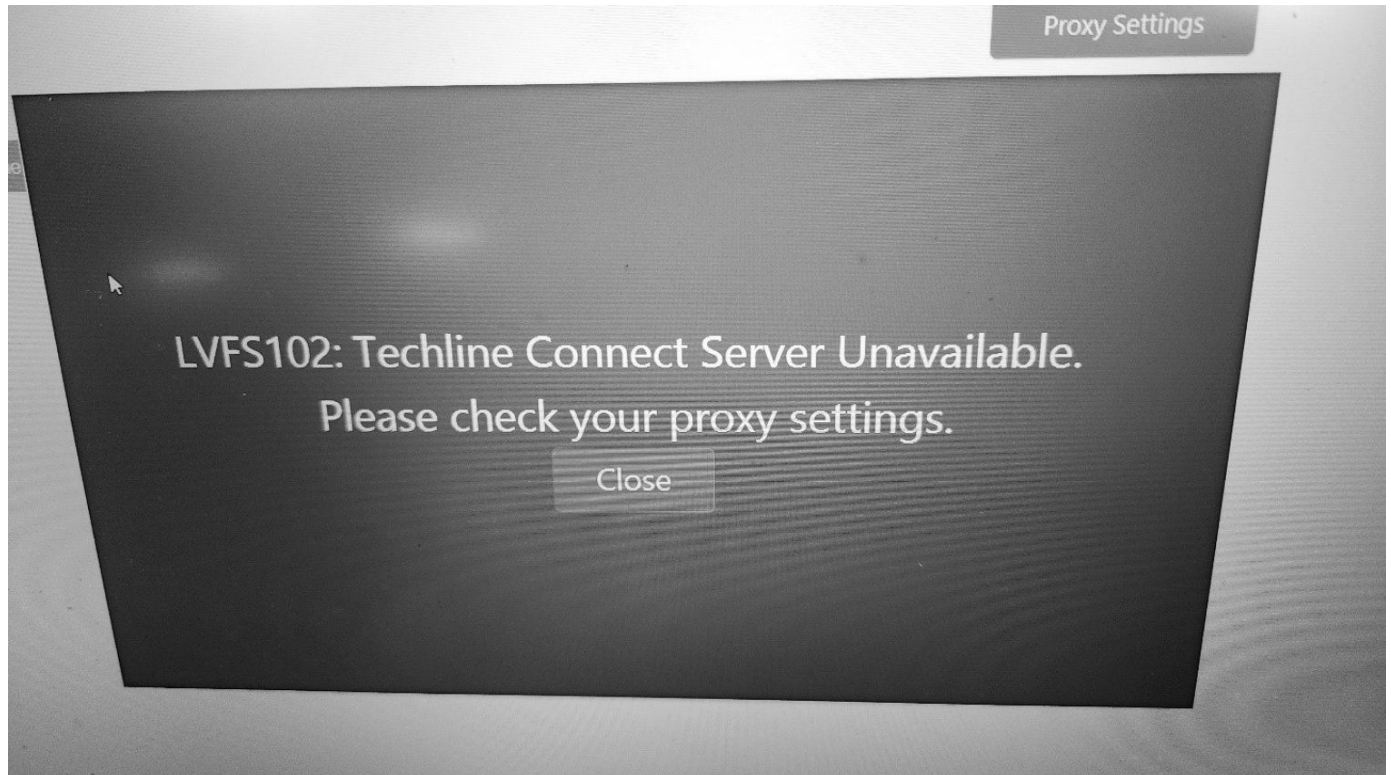
6689036

Note: If either of the following errors are received, this indicates a Techline connection concern. The recommended course of action is to exit from TLC completely and try again. If either failure persists, reboot the machine.
