Service Bulletin

Bulletin No.: 24-NA-226

Subject: Passenger Side Windshield A-Pillar Speaker Grill Cover Falling Off/Loose/Not Flush

Brand:	Model:	Model Year:		VIN:		Engine:	Transmission:
		from	to	from	to		
GMC	Hummer EV Pickup	2024	2025				
	Hummer EV SUV

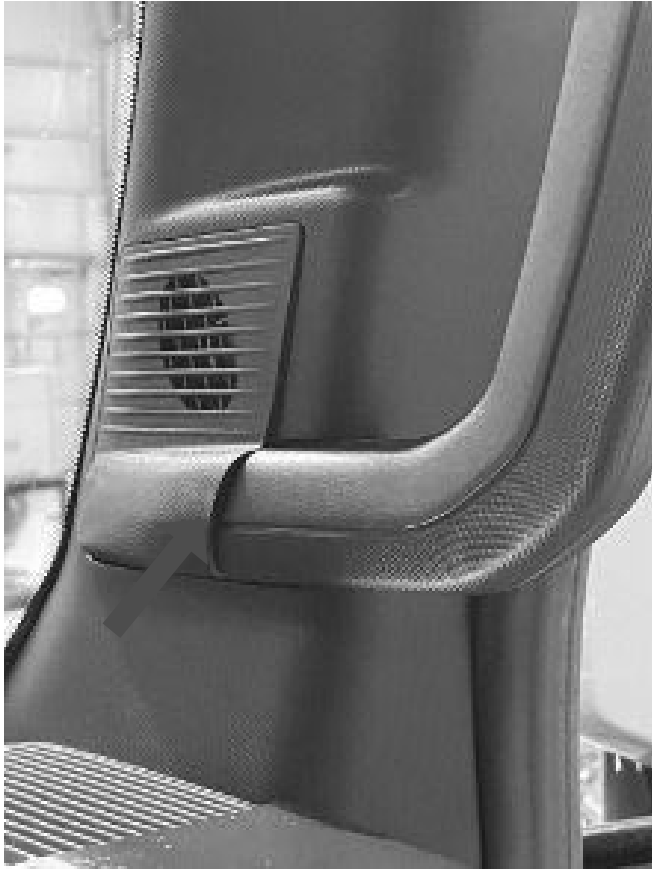
<p>6750484</p>
Correction	Refer to the Service Procedure below.

Involved Region or Country	North America
Condition	Some customers may comment on the passenger side Front Windshield A-pillar Speaker Grill Cover being loose, popping off, or not sitting flush with the assist handle.

Cause	<p>The cause of the condition may be that the assist handle mounting bosses are out of position causing the A-pillar trim to twist when the assist handle bolts are torqued.</p>
