# Service Bulletin

Bulletin No.: 24-NA-231  
Date: November, 2024

Subject: Front Headlamp Moldings Loose

| Brand: | Model: | Model Year: | | VIN: | | Engine: | Transmission: |
|---|---|---|---|---|---|---|---|
| GMC | Sierra EV | 2024 | 2025 | - | - | All | All |

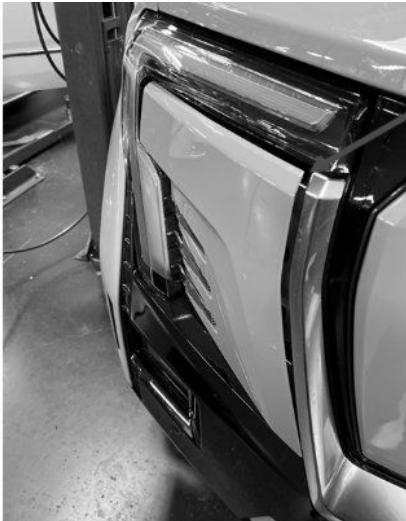
| Condition | <div><p>Some customers may comment on that the front headlamp moldings are not fully seated.</p></div> <div>6751017</div> |
| Cause | The cause of the condition may be the retainers that secure the headlamp moldings could have been misaligned during the assembly process. |

| Correction | Refer to the procedure outlined below. |
