Service Bulletin

Bulletin No.: 24-NA-255

Subject: Air Bag Warning MIL with DTC B14DC

Brand:	Model:	Model Year:		VIN:		Engine:	Transmission:
		from	to	from	to		
Cadillac	Escalade Escalade ESV	2023	2025				
Chevrolet	Suburban	2023	2025				
	Tahoe						
GMC	Yukon Yukon XL	2023	2025

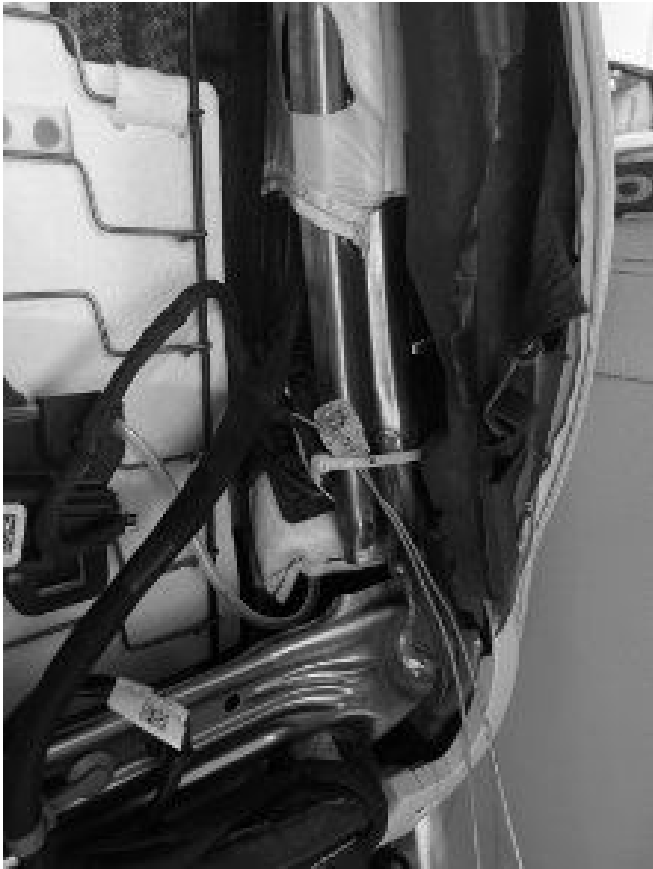
6763702

Involved Region or Country	North America
Condition	Some customers may comment on a Service Restraint System Message and/or SIR Warning MIL intermittently illuminated. When checking for DTC's, a B14DC will be found.
Cause	The cause of the condition may be due to a temporary loss of contact with the airbag connector terminals at the F106DA Front Seat Inboard Seat Back Airbag.
Correction	<p>Access the airbag connector:</p> <ol style="list-style-type: none"> 1. Disable the airbag, refer to <i>SIR Disabling and Enabling</i>. 2. Gain access to the Front Seat Inboard Airbag Connector, refer to <i>Front Seat Back Cover and Pad Replacement</i> and <i>Front Seat Inboard Seat Back Airbag Replacement</i>. 3. Locate the connector and perform a connector disconnect and reconnect of the F106DA Front Seat Inboard Seat Back Airbag connector, ensuring the connector is properly installed and seated. Clear DTCs. <ul style="list-style-type: none"> • If DTC B14DC returns, then replace the connector. Refer to the Service Procedure below. • If DTCs clear, then reseal the seat and return to the customer.

1. Locate the airbag connector and disconnect it.
