Technical Service Bulletin (TSB)
Noise From Steering Wheel While Turning

REFERENCE:	TSB: 08-251-24 GROUP: 08 - Electrical	Date:	December 10, 2024	REVISION:	–
VEHICLES AFFECTED:	2023 - 2024 (B1) Jeep Renegade 2023 - 2024 (H1) Jeep Commander 2023 - 2024 (M1) Jeep Compass This bulletin applies to vehicles built on or after December 28, 2023 (MDH 1228XX) and on or before November 14, 2024 (MDH 1114XX).			MARKET APPLICABILITY:	
				<input checked="" type="checkbox"/> NA	<input type="checkbox"/> MEA
				<input checked="" type="checkbox"/> SA	<input type="checkbox"/> IAP
				<input type="checkbox"/> EE	<input type="checkbox"/> CH
CUSTOMER SYMPTOM:	Customers may comment on the following: <ul style="list-style-type: none"> Noise when turning the steering wheel. 				
CAUSE:	Wire harness interference

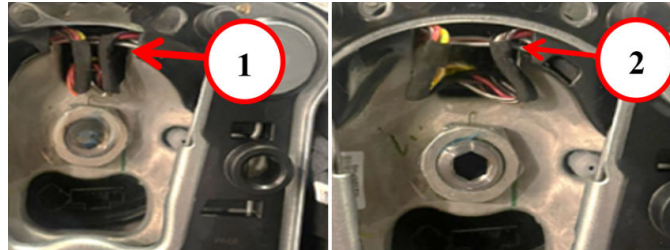
Fig. 1
Steering Wheel Harness

1 - Incorrectly Positioned Wire Harness
2 - Correctly Positioned Wire Harness

2. Is a noise heard coming from the steering wheel when turning?
 - YES>>> Proceed to [Step 3](#).
 - NO>>> This bulletin has been completed. Use Inspection LOP (XX-XX-XX-XX) to close the active RSU.
3. Disconnect and isolate the negative battery cable.
4. Remove the Driver Air Bag (DAB). Refer to the detailed service procedures available in DealerCONNECT/Service Library under: Service Info> 4110A11 - Volante - remocao/recolocacao para versoes com air bag.
5. Correct the position of the wire harness [Fig. 1](#).
