GENERAL MOTORS
DCS7095
URGENT - DISTRIBUTE IMMEDIATELY

Subject: N242471460 - Customer Satisfaction Program
Electrical Drive Unit Leak

Models: 2024 Chevrolet Blazer EV
2024 Chevrolet Equinox EV

N242471460 Electrical Drive Unit Leak

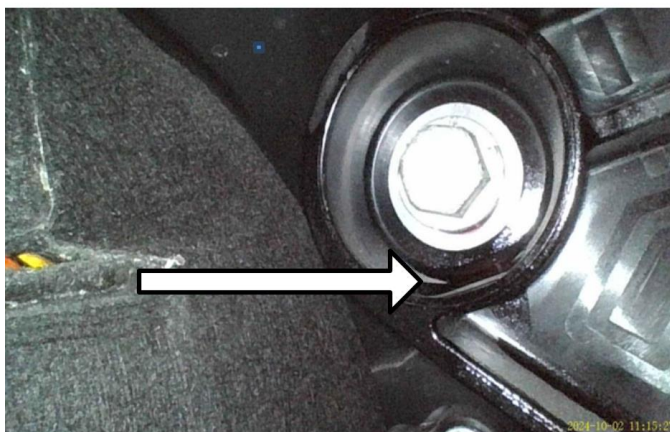
6750046

3. Inspect for the presence of fluid on and around the Right Side Drive Motor Mount.
 - If fluid is present on or around the Right Side Drive Motor Mount, proceed to step 5.

Note: For greater visual clarity, use an inspection mirror or a digital borescope for inspection of fluid.

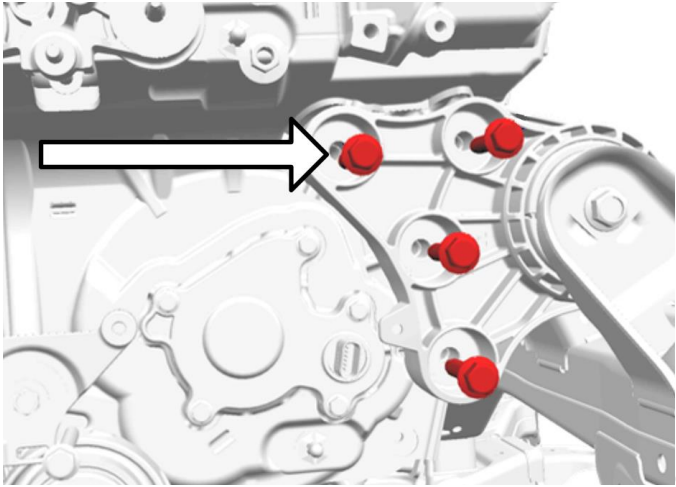
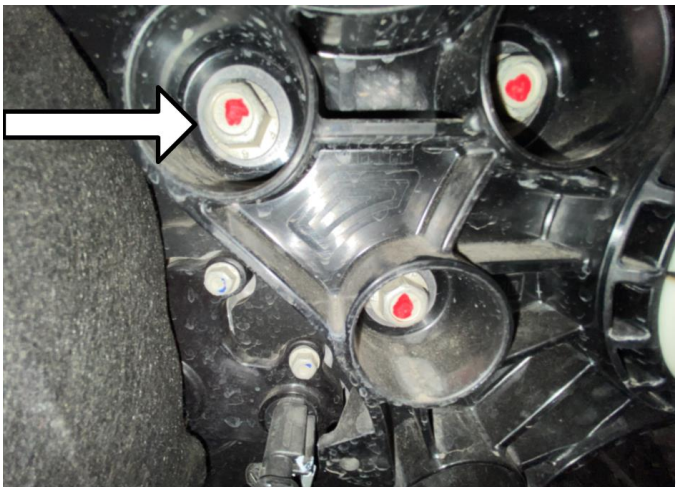
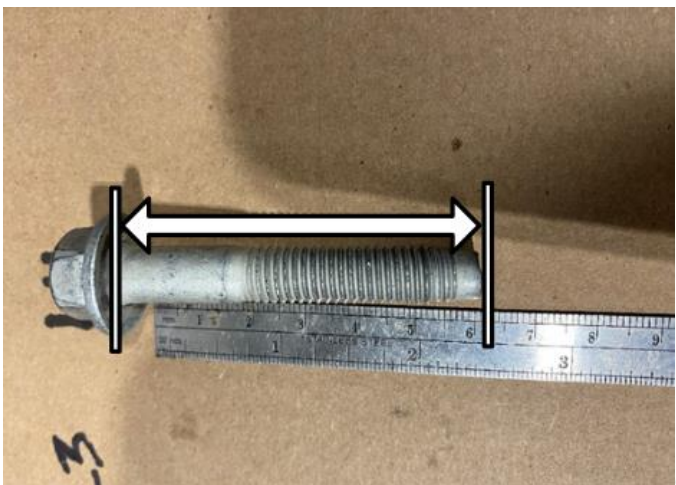
Note: Ensure the measurement is taken from the bottom of the bolt flange to the bolt tip, as depicted in the above graphic.

- Remove the RH Front Drive Motor Mount Fastener and measure the fastener.
 - If the RH Front Drive Motor Mount Fastener measures 55 mm, the Front Electric Drive Transmission Module is OK. Replace the fastener with a NEW fastener. Torque to 58 N•m (43 lb ft) and then an additional 75 degrees rotation. Reinstall the Front Compartment Center Sight Shield and Compartment Support (if equipped) . Refer to *Front Compartment Center Sight Shield Replacement* and *Front Trim Finish Compartment Support Replacement* in SI. No further action is required.
 - If the RH Front Drive Motor Mount Fastener measures 60 mm or more, the Front Electric Drive Transmission Module is NOT OK. Proceed to step 5.

Note: It is possible to access and remove the Drive Motor Mount fastener from the top of the vehicle.

Important: ONLY REMOVE THE DRIVE MOTOR MOUNT FASTENER AS DEPICTED IN THE ABOVE GRAPHICS. DO NOT REMOVE ANY ADDITIONAL FASTENERS AS PART OF THIS INSPECTION STEP.
