WARRANTY BULLETIN

NO: D-23-04

SUBJECT: 2018 - 2024 (Current) Jeep
Wrangler (JL) and 2020 - 2024 (Current)
Jeep Gladiator (JT) - Corrosion Warranty
Claim Simplification (Rev. G)

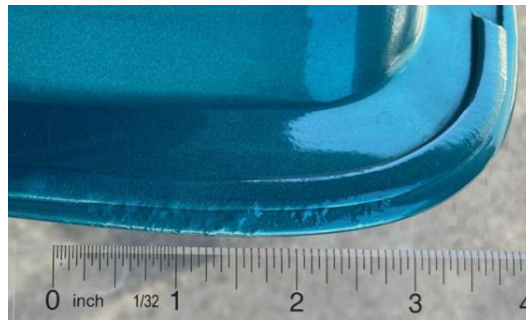
2. Corrosion found on the seam of the panel (Fig. 2)

Seam Panel Area Examples (Fig. 2)

Note: If corrosion is found on the seam of the panel, the door shell will be replaced. No additional sanding in the hinge or seam area is supported.
