FCA CARIBBEAN WARRANTY BULLETIN

NO: ID-23-03

SUBJECT: 2018 - 2024 (Current) Jeep
Wrangler (JL) and 2020 - 2024 (Current)
Jeep Gladiator (JT) - Corrosion Warranty
Claim Simplification (Rev. H)

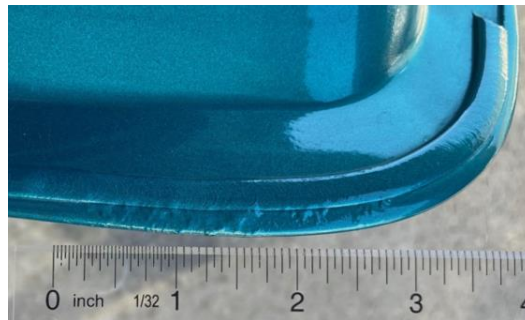
2. Corrosion found on the seam of the panel (Fig. 2)

Seam Panel Area Examples (Fig. 2)

Note: If corrosion is found on the seam of the panel, the door shell will be replaced. No additional sanding in the hinge or seam area is supported.
