Technical Service Bulletin (TSB)
Noise From Steering Wheel While Turning

REFERENCE:	TSB: 08-251-24 REV. A GROUP: 08 - Electrical	Date:	December 12, 2024	REVISION:	08-251-24
VEHICLES AFFECTED:	<p>2023 - **2025** (B1) Jeep Renegade 2023 - **2025** (H1) Jeep Commander 2023 - **2025** (M1) Jeep Compass This bulletin applies to vehicles built on or after **July 24, 2023 (MDH 07248XX)** and on or before November 14, 2024 (MDH 1114XX).</p>	MARKET APPLICABILITY:			
CUSTOMER SYMPTOM:	<p>Customers may comment on the following:</p> <ul style="list-style-type: none"> Noise when turning the steering wheel. 				
CAUSE:	Wire harness interference

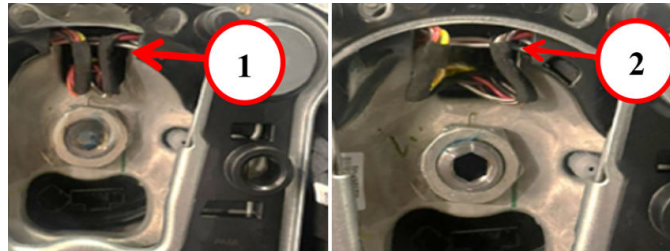
Fig. 1
Steering Wheel Harness

1 - Incorrectly Positioned Wire Harness
2 - Correctly Positioned Wire Harness

1. Turn the steering wheel full stop to the left and right five times.
2. Is a noise heard coming from the steering wheel when turning?
 - YES>>> Proceed to [Step 3](#).
 - NO>>> This bulletin has been completed. Use Inspection LOP (08-19-27-92) to close the active RSU.
3. Disconnect and isolate the negative battery cable.
4. Remove the Driver Air Bag (DAB). Refer to the detailed service procedures available in DealerCONNECT/Service Library under: Service Info> 4110A11 - Volante - remocao/recolocacao para versoes com air bag.
5. Correct the position of the wire harness [Fig. 1](#).

6. Turn the steering wheel full left and right to confirm the noise is eliminated.
7. Install the DAB. Refer to the detailed service procedures available in DealerCONNECT/Service Library under: Service Info> 4110A11 - Volante - remocao/recolocacao para versoes com air bag.
8. Connect the negative battery cable.
