Radio Over The Air Update from T25.XX (T25.26, T25.38, T25.43, T25.47, T25.49, T25.50) and T27.XX (T27.14, T27.38, T27.46, T27.6) to U29.42 and then from U29.42 to U33.43 Software Version (FOTA)

REFERENCE:	TSB: 08-254-24 GROUP: 08 - Electrical	Date:	December 13, 2024	REVISION:	-							
VEHICLES AFFECTED:	2023 (WL) Jeep Grand Cherokee/Grand Cherokee L 2023 (W7) Jeep Grand Cherokee (India) This bulletin applies to vehicles equipped with a Global Telematics Box Module (TBM) (Sales Code RDG) and one of the following radios: <ul style="list-style-type: none"> ● Uconnect 5 Nav w 10.1" Display (ROW+DAB) (Sales Code UUN). ● Uconnect 5 Nav w 10.1" Display (JPN) (Sales Code UTN). ● Uconnect 5 Nav w 10.1" Display (KOR) (Sales Code URN). ● Uconnect 5 Nav W 10.1" Display (ROW-DAB) (Sales Code UPN). 			MARKET APPLICABILITY:

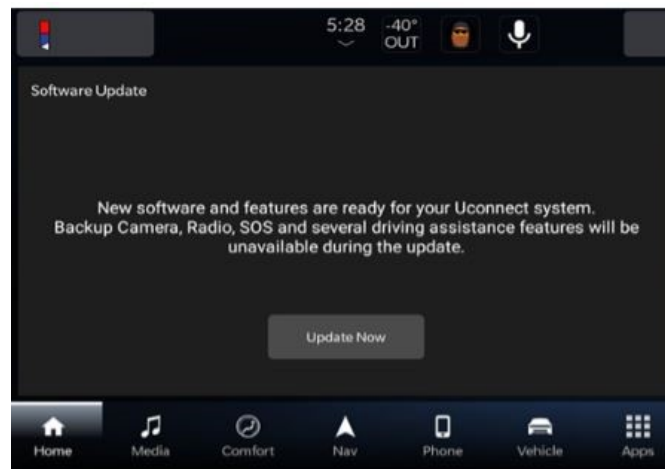
Fig. 1

Software Acceptance Screen

1. The vehicle needs to be in 'Park'. The ignition needs to be in the off position.
2. If the customer selects “Update Now” [Fig.1](#) they can shut off the vehicle and leave. The update will be completed automatically.
