**Technical Service Bulletin (TSB)**  
**Power Transfer Unit (PTU) Failure**

<b>REFERENCE:</b>	<b>TSB:</b> 21-057-24 <b>GROUP:</b> 21 - Transmission and Transfer Case	<b>Date:</b>	December 13, 2024	<b>REVISION:</b>	—
<b>VEHICLES AFFECTED:</b>	<b>2021 - 2024 (M6) Jeep Compass</b> <b>2023 - 2024 (H6) Jeep Meridian</b> <b>This bulletin applies to:</b> <ul style="list-style-type: none"> <li>• <b>M6 vehicles built on or after December 23, 2020 (MDH 1223XX)</b>  <b>Equipped with a 9-Spd 948TE Auto Transmission (Sales Code DFH).</b></li> </ul>			<b>MARKET APPLICABILITY:</b>	
				<input type="checkbox"/> NA	<input type="checkbox"/> MEA
				<input type="checkbox"/> SA	<input checked="" type="checkbox"/> IAP
				<input type="checkbox"/> EE	<input type="checkbox"/> CH
<b>CUSTOMER SYMPTOM:</b>	<b>Customers must experience a Malfunction Indicator Lamp (MIL) illumination and the vehicle must exhibit/set one or more of the following Diagnostic Trouble Codes (DTCs):</b> <ul style="list-style-type: none"> <li>• C2270-77 - Power Transfer Unit PTU Electronic Disconnect Actuator EDA Sensor - Commanded Position Not Reachable.</li> <li>• C2290-92 - EDA Motor Free Running - Performance Or Incorrect Oper

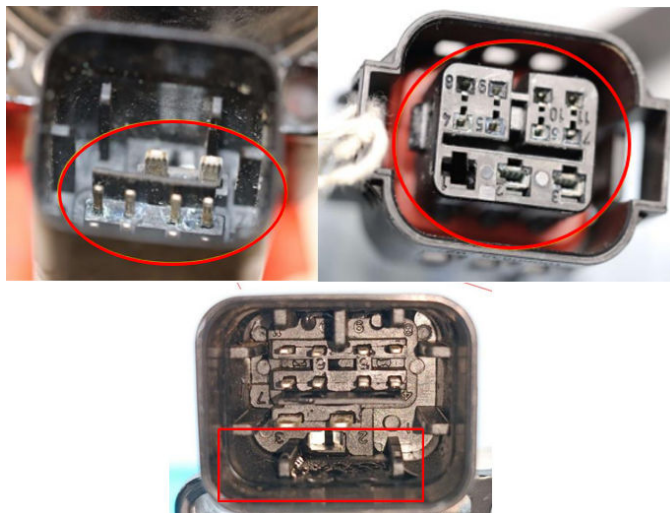
**Fig. 1**  
Wire Harness Connectors

5. Inspect for evidence of moisture on the connector pins at both the PTU and the shift actuator wire harness connectors [Fig. 1](#).

6. Is moisture present on the connector pins?
- YES>>> Proceed to [Step 7](#).
  - NO>>> Proceed to [Step 11](#).
7. Replace the wire harness.
8. Clear any DTCs that may have been set.
9. Road test the vehicle for 8-10 km (5-6 miles).
10. Is DTC C2270-077, C2290-92, C2280-92, C2240-92, C2120-13, C2120-14 or C2120-15 present?
- YES>>> Proceed to [Step 11](#).
  - NO>>> This bulletin has been completed.
11. Remove the shift actuator from the PTU. Refer to the detailed service procedures listed in DealerCONNECT> Service Library under: 21 - Transmission and Transfer Case / Power Transfer Unit / Actuator, Shift / Removal.

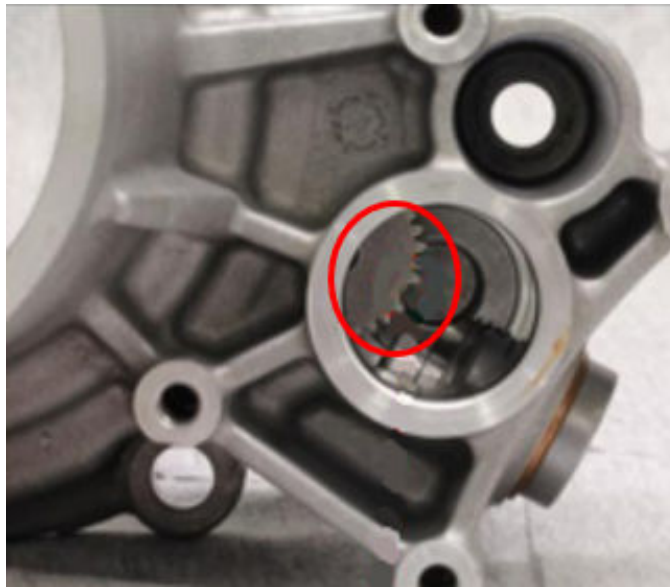
**Fig. 2**  
Intermediate Gear

12. Inspect if the intermediate gear has any broken teeth [Fig. 2](#).

13. Does the intermediate gear have any broken teeth?

14. Replace the PTU along with the mating wire harness. Refer to the detailed service procedures listed in DealerCONNECT> Service Library under: 21 - Transmission and Transfer Case / Power Transfer Unit / Removal and Installation. Proceed to [Step 16](#).

15. Replace the shift actuator along with the mating wire harness. Refer to the detailed service procedures listed in DealerCONNECT> Service Library under: 21 - Transmission and Transfer Case / Power Transfer Unit / Actuator, Shift / Removal and Installation.
