<b>REFERENCE:</b>	<b>TSB:</b> 23-058-24 REV. A <b>GROUP:</b> 23 - Body	<b>Date:</b>	December 13, 2024	<b>REVISION:</b>	23-058-24
<b>VEHICLES AFFECTED:</b>	<p><b>**2024** - 2025 (M1) Compass (Brazil)</b>  <b>**2024** - 2025 (N4) RAM Rampage</b>  <b>**2024** - 2025 (B1) Jeep Renegade</b>  <b>This bulletin applies to:</b></p> <ul style="list-style-type: none"> <li>• M1 vehicles built <b>**on or after January 16, 2024 (MDH 0116XX) and on or before January 20, 2024 (MDH 0120XX)**</b>.</li> <li>• N4 vehicles built <b>**on or after March 19, 2024 (MDH 0319XX) and on or before March 23, 2024 (MDH 0323XX)**</b>.</li> <li>• B1 vehicles built <b>**on or after January 22, 2024 (MDH 0122XX) and on or before February 24, 2024 (MDH 0224XX)**</b>.</li> </ul>			<b>MARKET APPLICABILITY:</b>	
<b>CUSTOMER SYMPTOM:</b>	<p><b>Customers may experience the following:</b></p> <ul style="list-style-type: none"> <li>• Loose seatback on the passenger front seat.</li> </ul>

<b>CAUSE:</b>	Improper torque applied

This bulletin involves removing the passenger seat and tightening the fasteners that join the seatback to the seat.

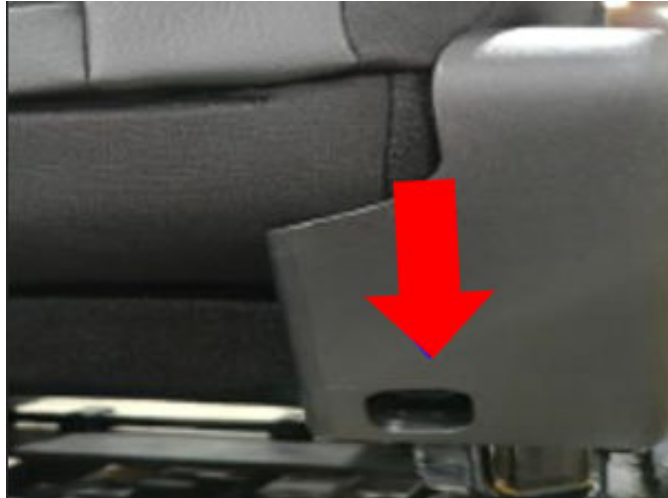
**Fig. 1**

Cover Fastener Location

1. Disconnect the negative battery cable.
2. Remove the passenger seat. Refer to the detailed service procedures listed in DealerCONNECT>Service Library> under: 7045A10 - Banco dianteiro (um) - esq. ou dir. - remocao/recolocacao.
3. Remove the fastener on the outer back of the plastic cover [Fig. 1](#).

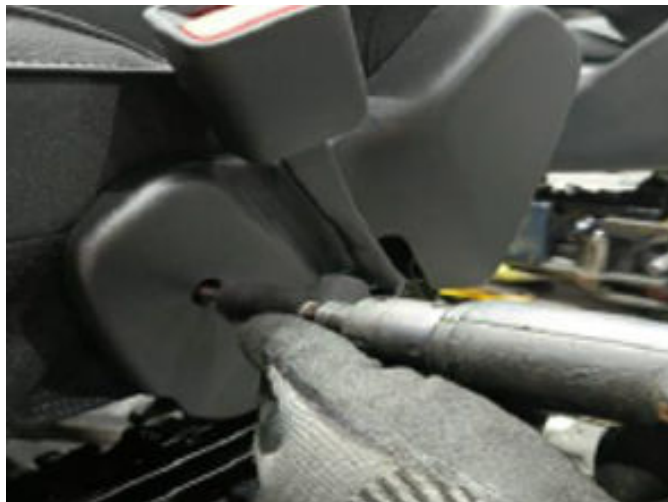
**Fig. 2**

Cover Fastener Location

4. Remove the other fastener and remove the cover from the rear inner guide of the front seat [Fig. 2](#).

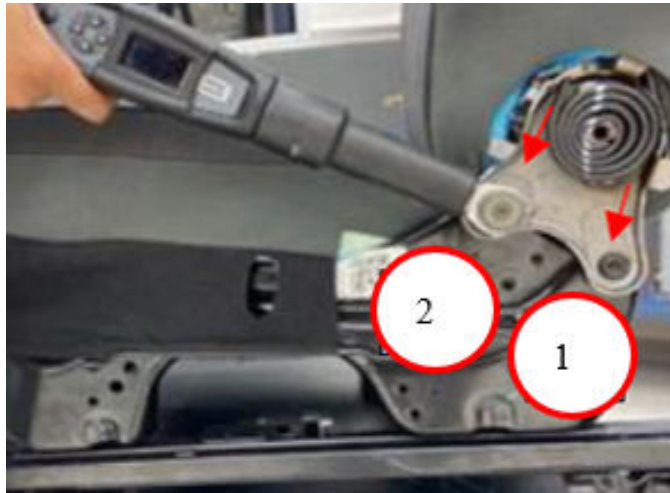
**Fig. 3**  
Two Fasteners

1 - Rear Fastener  
2 - Front Fastener

5. Tighten the two fasteners to 60 N·m (44.2 ft. lb.) in the sequence shown in [Fig. 3](#).

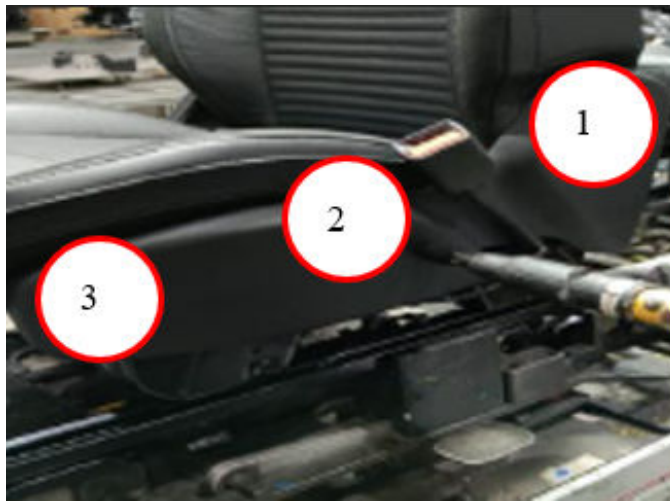
**Fig. 5**  
Cover Removal Points

- 1 - Rear Of The Cover
- 2 - Top Of The Cover
- 3 - Front Of The Cover

4. Remove the fastener on the side of the plastic cover [Fig. 5](#)

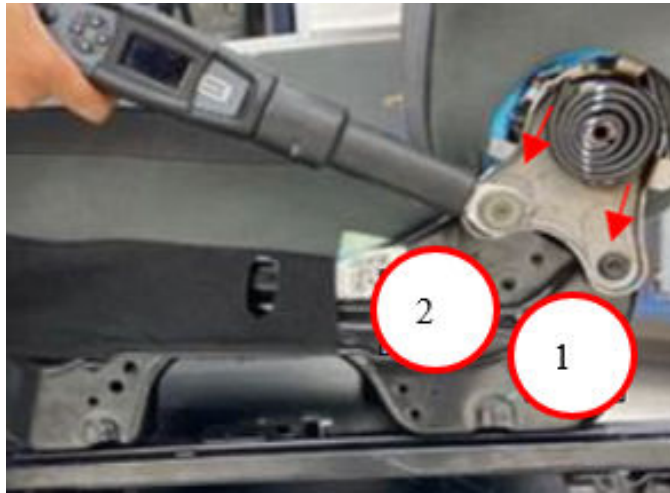
**Fig. 9**  
Two Fasteners

1 - Rear Fastener  
2 - Front Fastener

8. Tighten the two fasteners to 60 N·m (44.2 ft. lb.) in the sequence shown in Fig. 9.
