## **REPAIR DOCUMENT**

### **Kemlite Roof Rivet Edge Distance Inspection**

Repair Document #: **RD-00107A**

Date: Revised December 16, 2020

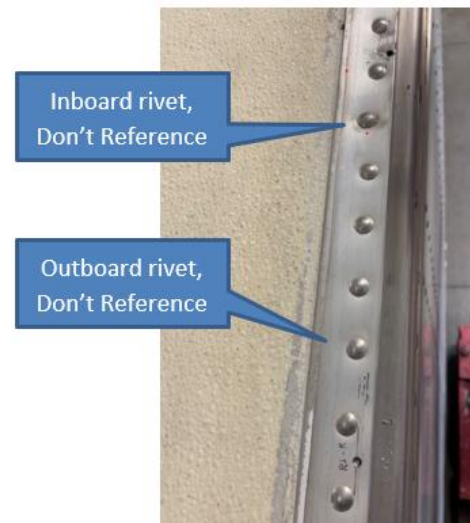
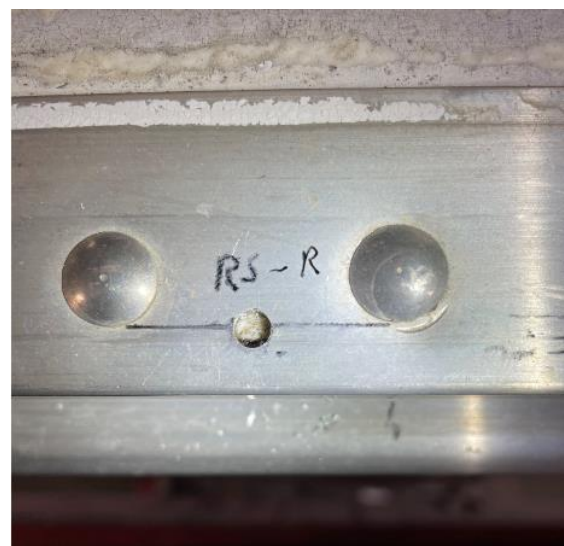
4. At the approximate center of the line drill a 3/16" hole through the J-channel **but not through the Kemlite below it**. With a battery powered drill this can be done with light pressure and care. If you have problems, then a drill stop on the tip of the drill bit may be necessary. An air powered drill is harder to control and will need a drill stop.

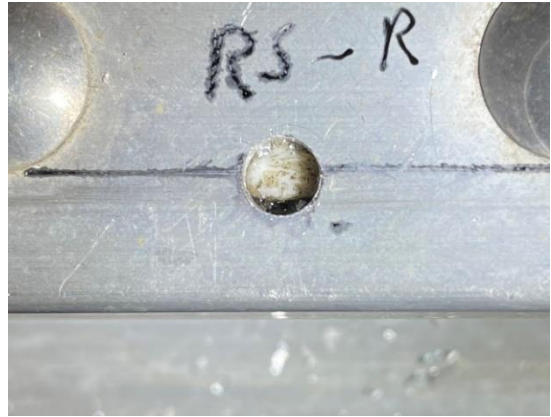
5. If the Kemlite sheet extends to the outboard edge of the hole or close to it as shown in the picture, the rivet edge distance is **OK**.
- Mark the J-channel near the hole with a check mark to indicate it is OK.

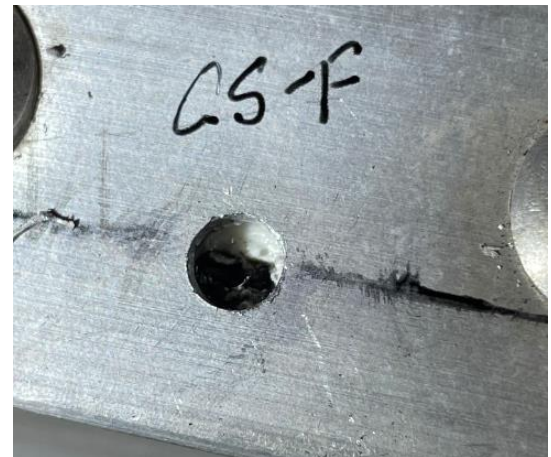
6. If the Kemlite does not extend to near the outside edge of the hole it is **NOT OK** and has a rivet edge distance issue.
- Mark the J-channel near the hole to with an X to indicate not OK.

7. If the edge distance is **NOT OK** than perform additional inspections on approximate 4 ft increments (joint lap spacing) until adequate rivet edge distance is found.

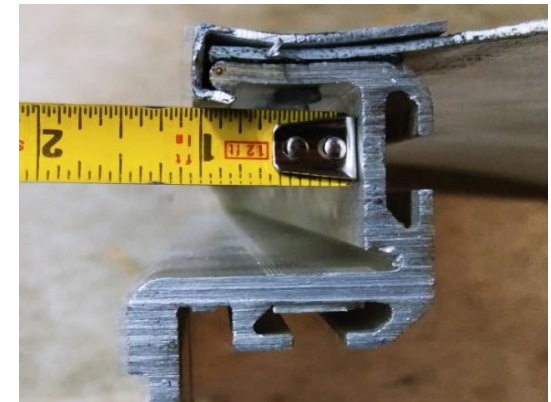
9. Measure from the top rail recess to the outside of the J-channel
- Should be 15/16" to 1-1/16".
